Quantitative evaluation of the damage to RC buildings caused by the 2023 southeast Turkey earthquake sequence

Earthquake Spectra

2024, Vol. 40(1) 505–530

DOI: 10.1177/87552930231211208

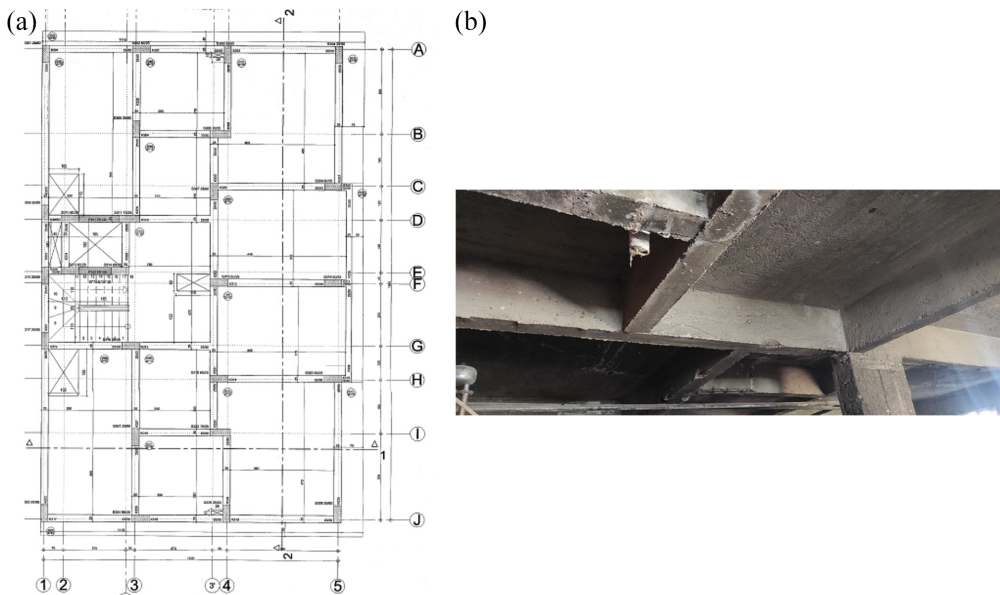
Figure 2. Irregular framing examples: (a) floor plan and (b) floor soffit.

1. Lack of structural walls (Supplementary Material 1);
2. Irregular column lines (Figure 2);
3. Differences in lateral stiffness in the two principal floor plan directions;
4. Insufficient separation between buildings leading to pounding;
5. Beam axes offset from column axes (Supplementary Material 1);
6. Beams framing into other beams instead of columns (Supplementary Material 1);
7. Short beams (not detailed to resist high shear forces) (Supplementary Material 1);

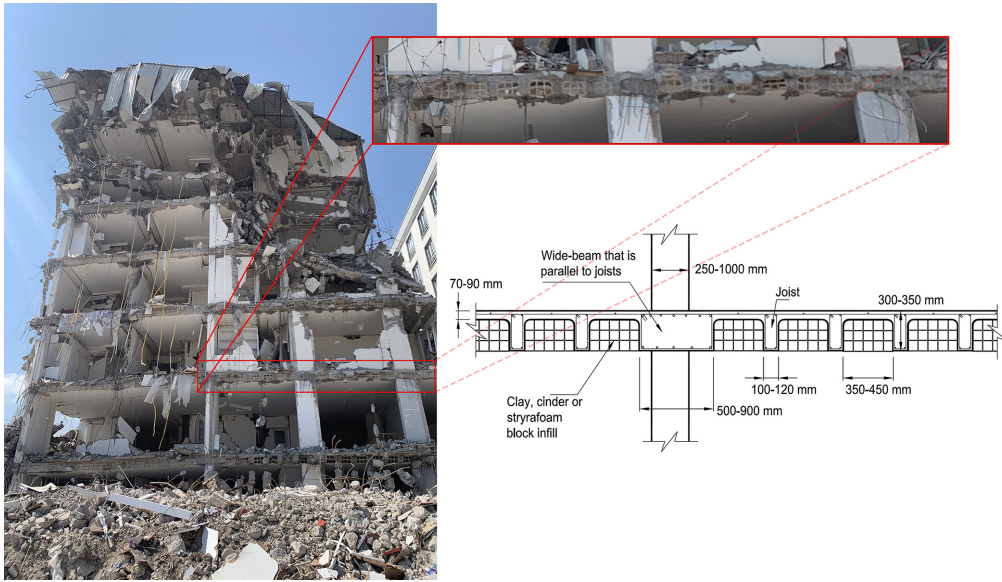
RC frames with shallow beams. In nearly 25% of the structures surveyed, the flooring system consisted of “shallow beams” and one-way joists. Typical dimensions of shallow-beam frames that are often called ribbed slabs in the United States (called “asmolen” or “disli doseme” systems in Turkey) are shown in Figure 3 together with a photograph of such a frame during demolition (building located in Nurdagi, Gaziantep). In these frames, beam depths did not exceed the depths of the joists (typically 30–35 cm) in the interest of producing a flat ceiling. Joists were formed during casting by using rows of hollow concrete masonry units (CMU) that remained in place and became part of the floors.

Figure 3. Partially demolished reinforced concrete frame with shallow beams and typical dimensions of one-way joist-slab shallow-beam frames in Turkey.

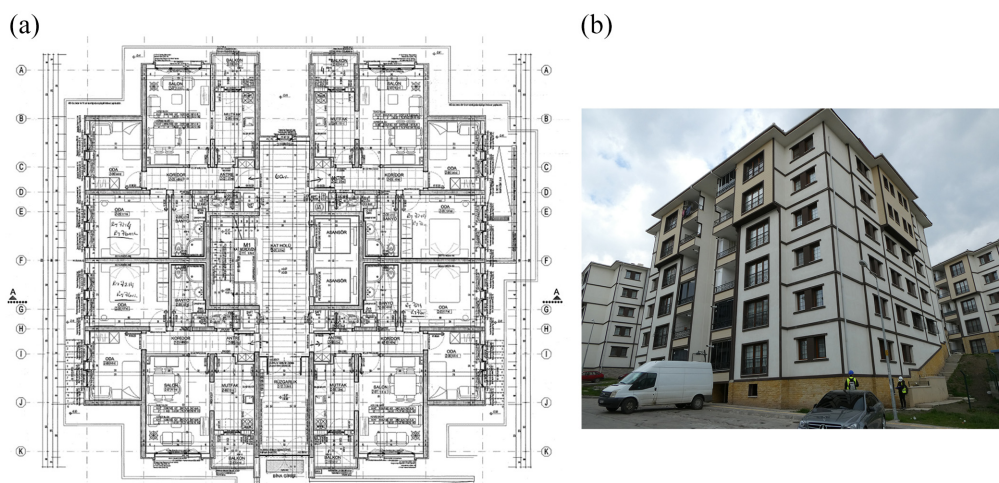
Wall construction. A limited number of buildings were observed to have been built with a method known as “tunnel-form construction” (illustrated here: https://youtu.be/_j-FRe8Ay9s). These structures tend to have abundant structural RC walls (occupying 2% to 6% of a typical floor plan). They were observed to be configured in one of two ways: (1) including similar amounts of wall in each principal floor plan direction, or (2) with most walls oriented in a single floor plan direction. The latter cases were observed to have more signs of structural distress, whereas buildings with well-distributed walls in both orthogonal plan directions commonly performed well, exhibiting only light damage (Figure 5).

Figure 5. Wall structures with similar amounts of wall in each principal floor plan direction: (a) typical floor plan and (b) example of wall building built by Housing Development Administration of Turkey (TOKI-Toplu Konut Idaresi Başkanlığı) at Dulkadiroglu, Kahramanmaraş.

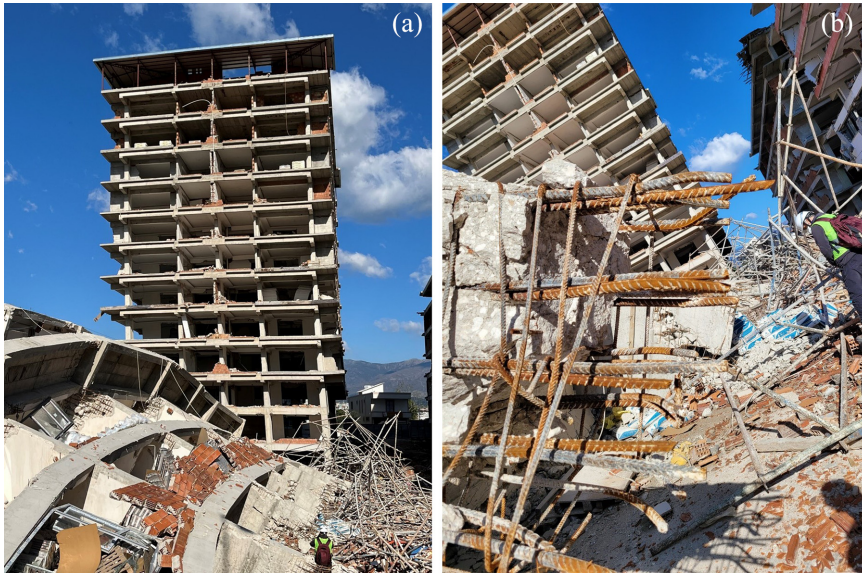
The two 13-story buildings in Figure 15 were in Antakya. They were reported to have been built by the same contractor following the same set of drawings. The detailing observed was one of the best in that (1) crossies were present, (2) tie spacing seemed uniform and acceptable, and (3) splices had enough confinement and cover to develop the strength of and reach fracture in longitudinal bars (Figure 15b). A permanent drift ratio of 6% was measured in the first story of the standing building. For an assumed value of $PGV = 1.3m/s$ (consistent with the most demanding spectrum in Figure 1), and $T = 1.3$ s, the roof drift can be estimated to have been $PGV \times T = 1.3 \times 1.3 = 1.7m$ (Puranam et al., 2019). For an approximate height of 39 m, roof drift ratio would be $1.7/39 = 4.3\%$, consistent with the observed permanent drift considering that the story drift ratio can be as high as 1.3 to 1.5 times the roof drift ratio.

These drift estimates are large enough to suspect overturning caused by second-order (p-delta) effects. The example illustrates the need to control drift to avoid collapse even if detailing is sufficient to produce a ductile response. The standing structure in Figure 15

had $WI=0.04\%$ and $PI=0.11\%$. The wall and column densities were 0.5% and 0.8% , respectively.

Figure 15. Building complex in Antakya: (a) building complex still standing with an approximate residual drift of 6% in the first story, and (b) identical structure that had collapsed (seen in the foreground of Figure 15a)

This example and the previous section suggest strongly that to control damage, in Turkey and elsewhere, it is necessary to decrease drift demand through design limits leading to more robust structures. Detailing is necessary (to ensure stable hysteretic response) but not sufficient (to control damage).
