Seismic performance assessment of structural systems in the aftermath of the 2023 Kahramanmaraş earthquakes: Observations and fragility analyses

Earthquake Spectra

2025, Vol. 41(1) 198–218

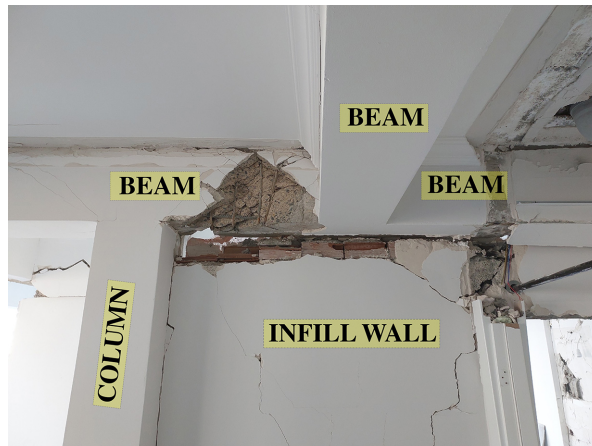
Figure 4. Example of an indirect beam-to-beam support (beam framing into another beam).

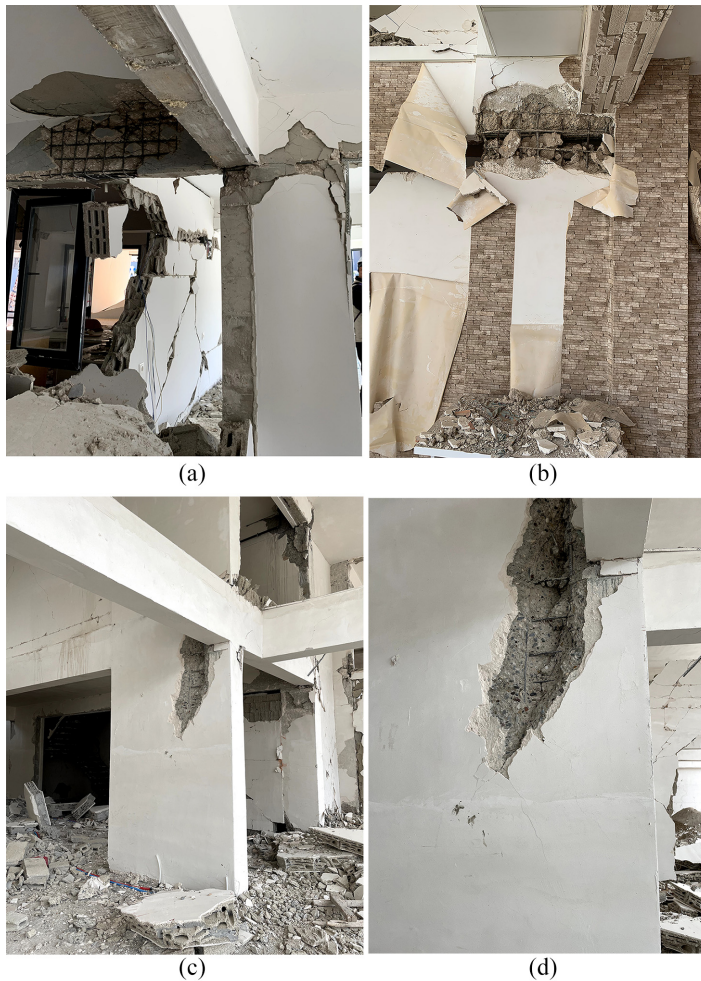
resulting in torsional moments and substantial damage to both the column and the beam connected in the column's stronger direction. Figure 5c and d illustrates heavy shear that ruptured the edge of the column, while the rest of the column face remains unaffected, implying that the only resisting part of the vertical elements is usually where they meet the beams. Employing more square-shaped cross-sections for columns would prevent such behavior under extreme loading.

Figure 5. Damage caused by beams connecting column's edges in the weak direction. (a) damage on intersecting beam; (b) heavy damage on the column; (c) heavy shear rupture on the column; and (d) zoomed-in view of the shear rupture shown in Figure 5c.

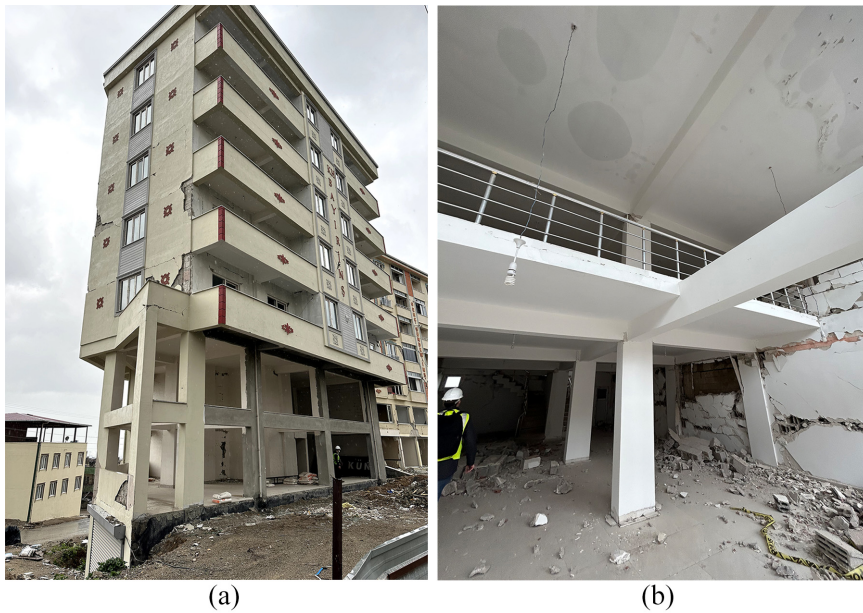
In many urban residential buildings, ground-level spaces are allocated for commercial use, a common practice that influences architectural design. As a result, the ground floor is typically higher than the upper floors, occasionally reaching up to 6 m. These raised ground floors often include mezzanines, contributing to the formation of a soft story. In addition, the floor plan typically widens above the ground floor, creating heavy overhangs (Figure 6). Moreover, there is a shift in the position of perimeter beams. This shift in the perimeter frame leads to having slab bands instead of conventional beams, as given in Figure 3b. Figure 7 illustrates structural damage associated with these frame discontinuities. As illustrated by the red arrow markers, the beam continuity is disrupted around the perimeter of buildings with overhangs. This disruption causes a decrease in the lateral stiffness of the frame, resulting in heavy damage.

Figure 6. (a) Building with a ground floor used as a commercial store; and (b) mezzanine from one of the surveyed buildings.

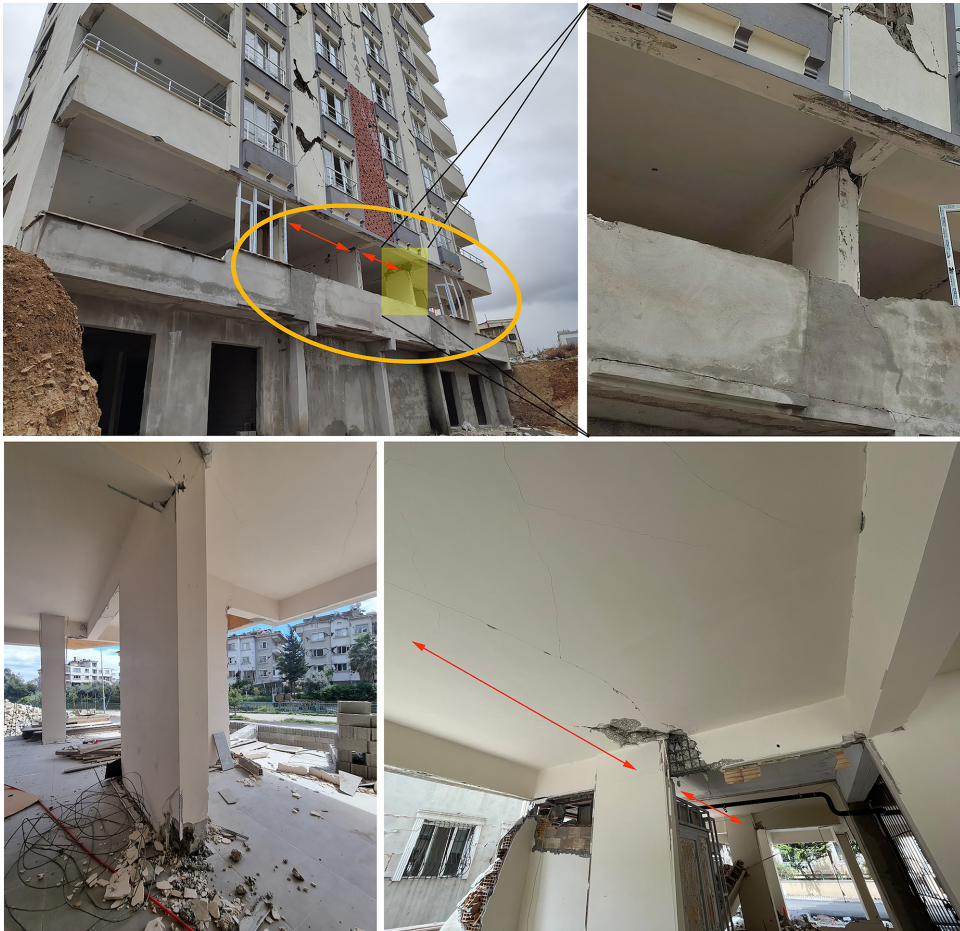
Figure 7. Damaged structural elements due to frame discontinuity.

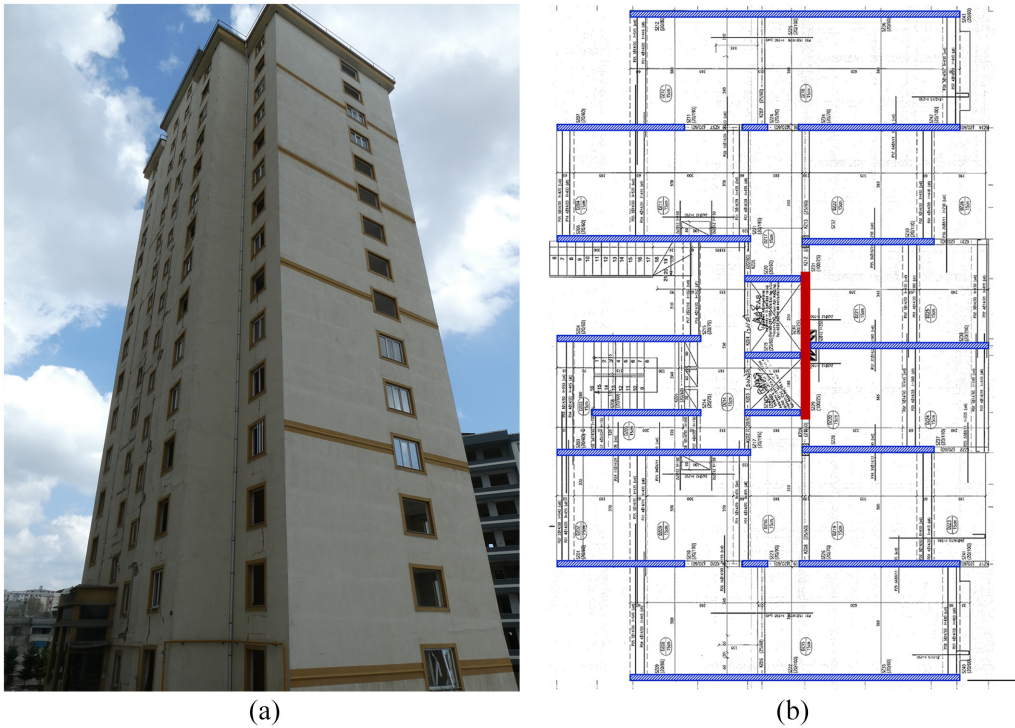
Figure 8 shows a severely damaged RC wall building in Kahramanmaraş. This building is one of the apartments in a complex where all buildings suffered severe damage, and one collapsed. Examination of the floor plans revealed that they had only a single RC wall (shown with red rectangle) in the long direction, while all other walls were in the short direction (shown with blue rectangles).

Figure 8. Severely damaged RC wall construction in Kahramanmaraş: (a) photo of the building; and (b) plan of the building with a highlighted RC wall layout.

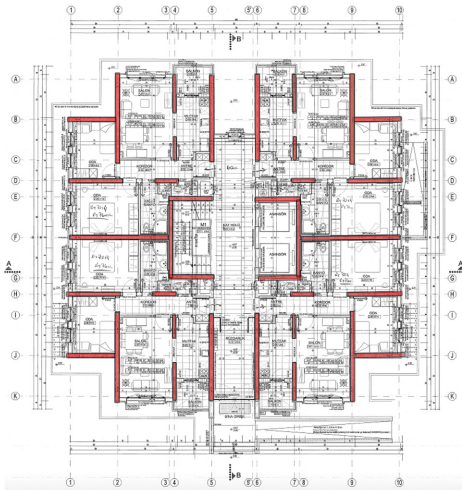
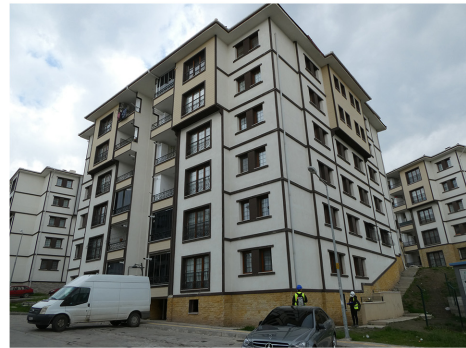
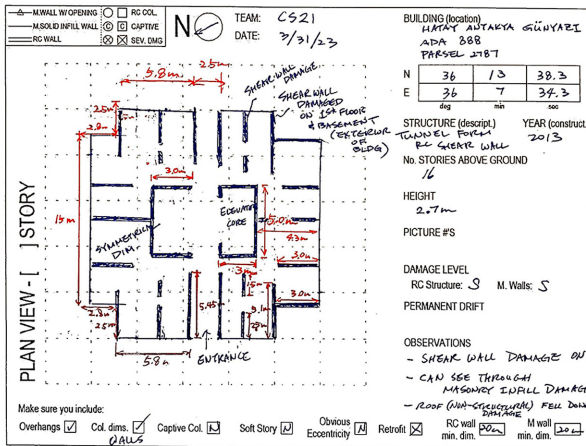
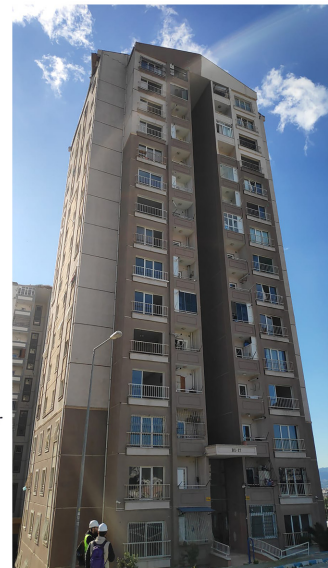
Figure 9 presents two RC wall buildings located in different complexes along with their respective floor plans. Both buildings experienced comparable seismic demands during the earthquakes. These buildings were commissioned by the Mass Housing Development Administration of Türkiye and constructed using reusable tunnel formwork, featuring identical floor plans despite their differing number of stories. Consequently, both buildings possessed the same amount of shear walls in their ground floors but exhibited different wall indices. The taller buildings had lower wall indices compared to the shorter ones, resulting in severe damage in the former and no damage in the latter. Similarly, it was observed that another eight-story RC wall building, which showed only minor signs of non-structural damage, had sufficient wall indices in both directions.

Figure 9. Different RC wall buildings with the same floor plan from Kahramanmaraş and Hatay, respectively: (a) floor plan; and (b) photo of the 6-story building with no structural damage; (c) floor plan; and (d) photo of the 16-story building with severe damage.

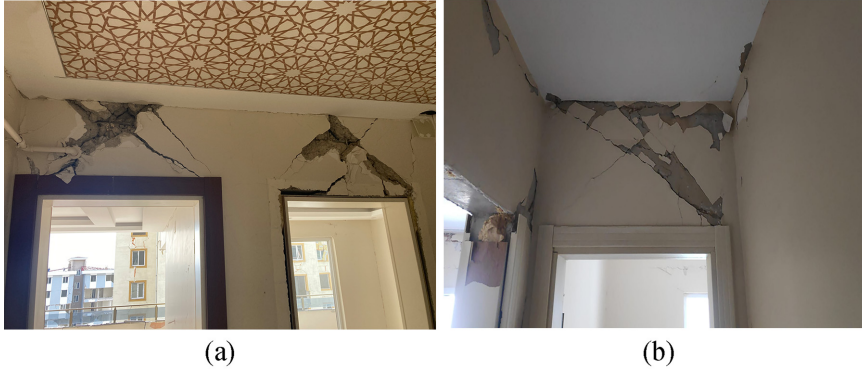
The most common structural damage to RC wall structures observed to be shear failures of short/coupling beams. Figure 10a and b shows damaged coupling beams of RC

wall buildings. The main reason of shear failures in short/coupling beams originates from the lack of diagonal reinforcement to address the shear demands. More specifically, practitioner engineers in the region benefit from CAD software which is expected to help them during the analysis and design process. These software rely on the checks defined in the Building Earthquake Regulation of Türkiye-2018 (Ministry of Interior of the Republic of Türkiye, 2018) to guide the engineer on whether the beam needs to be considered as a short/coupling beam or not. One of the most commonly used CAD software in the region does not allow users to manually design diagonal reinforcement if the beam is not considered a short/coupling beam leading to a lack of sufficient reinforcement.

Figure 10. Shear failures in coupling beams of RC wall structures: (a) From the building in Kahramanmaraş given in Figure 8. (b) From the building in Hatay given in Figure 9d.

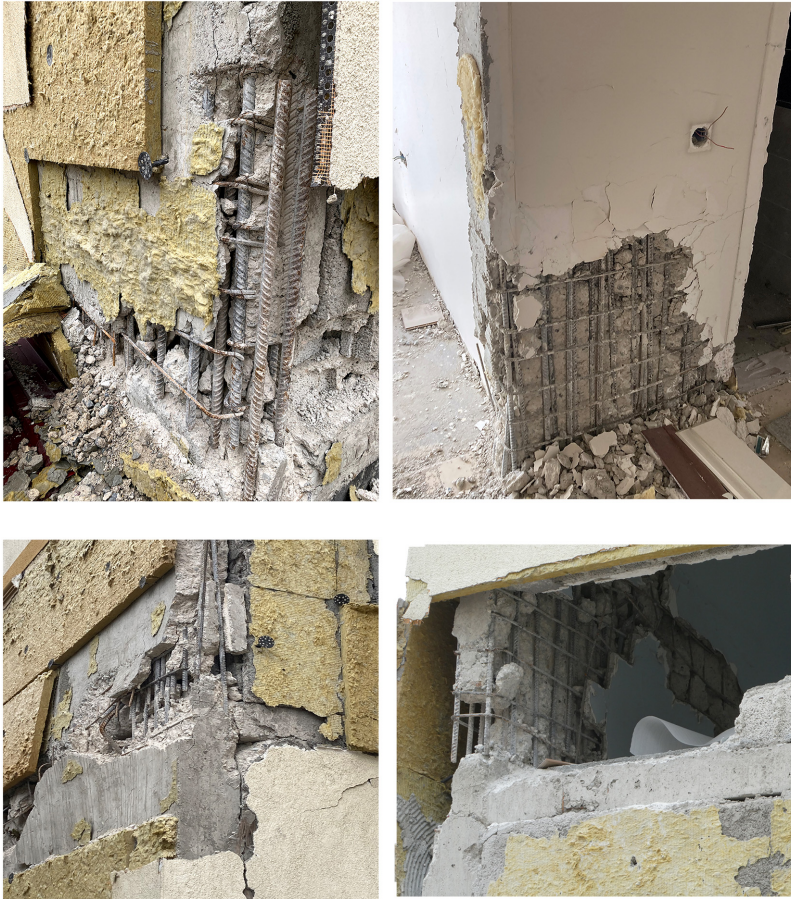
The primary damage to RC walls was observed to be lap splice failures. The inspected buildings exhibited heavily damaged shear walls due to the failure of the lap splice regions at wall bases. It is worth noting that the actual forces in longitudinal bars in RC wall could exceed the design forces so that the lap splices in the boundary regions may be forced to resist these forces. Therefore, these lap splices are susceptible to sudden failure, and even if they do not immediately fail, they introduce abrupt bending and areas of elevated strain concentration at their extremities. The Building Earthquake Regulation of

Figure 11. Lap splice damage in RC shear walls.

Türkiye-2018 (Ministry of Interior of the Republic of Türkiye, 2018) explicitly prohibits the utilization of lap splices in the longitudinal reinforcement of columns near the ends of members where yielding is anticipated due to increased flexural moments. However, the Building Earthquake Regulation of Türkiye-2018 does not specify any requirement for the longitudinal reinforcements within the boundary regions of shear walls. ACI (2019) 318-19 restricts the placement of lap splices in the critical regions of the RC walls, where yielding of the rebars is expected due to lateral displacements. During the inspections, most shear walls were observed to have experienced failures in the lap splices at their base (Figure 11). These shear walls were also subjected to higher lateral loads during the earthquakes, causing severe damage to the members at the ground level of the structures. Figure 12 shows buckling and rebar ruptures to the longitudinal reinforcements of structural walls at the ground level.

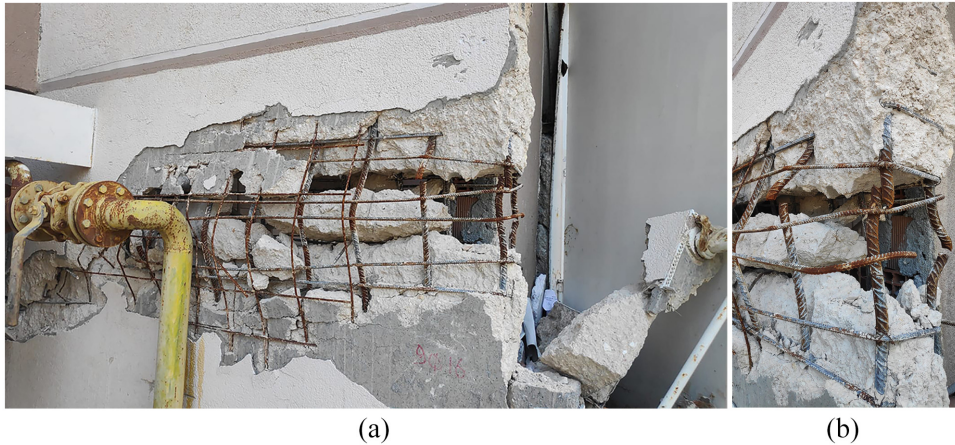
Figure 12. Damage to structural walls: (a) Buckling of rebars. (b) Rupture of rebars.
