Condition assessment of different historic bridges using Non Destructive Techniques (NDT) with FTIR analysis in Izmir after the Samos Island earthquake

Gokhan Kilic*

Abstract

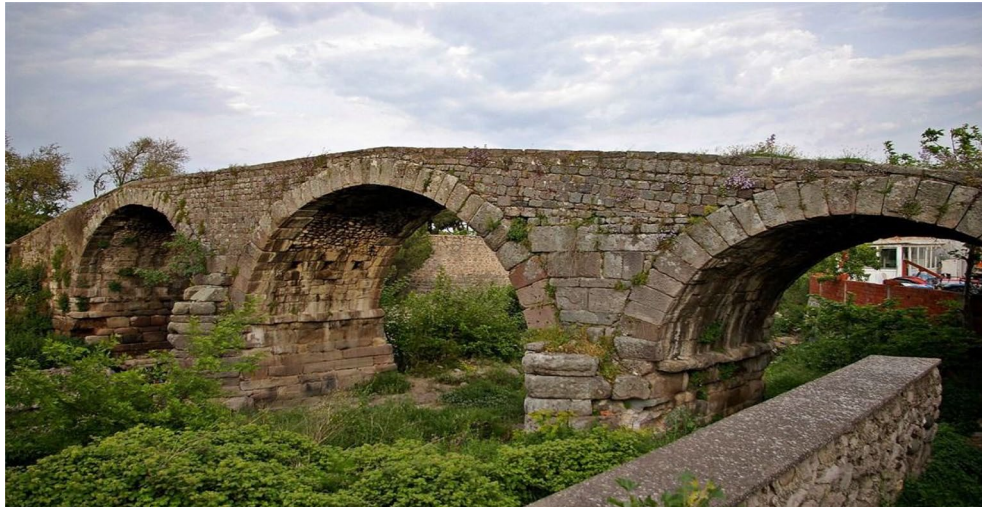
Fig. 2 Front View of Uc Kemer Bridge

The first case study bridge, called Uc Kemer Bridge (Fig. 2) and built in the Roman period, is located in the Bergama district, İzmir province, specifically across the Selinus Brook in the city. The largest arch is 10 m high; the width is 9.60 m; the bastion is 4.50 m wide and 56.40 m long. FTIR analysis was used to pinpoint the origins of its rock and stone formations.

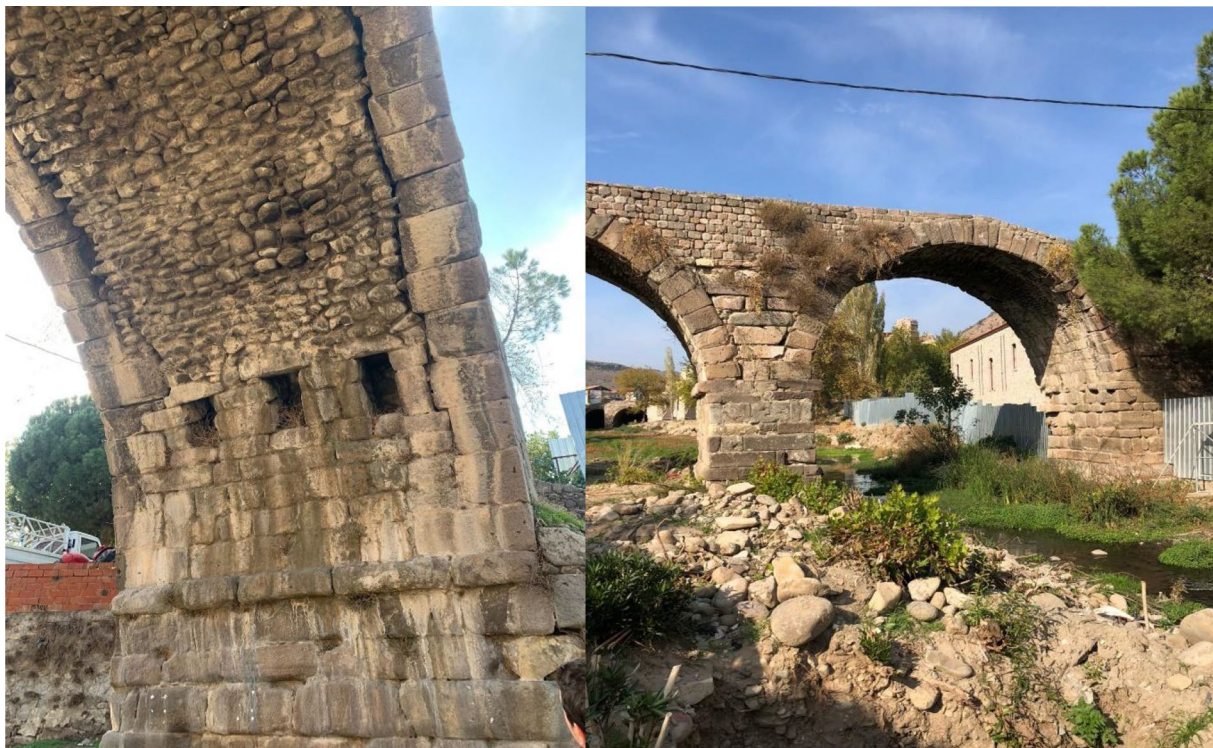
Fig. 3 Side and Back View of Uc Kemer Bridge

The visual inspection showed that, following a flood, the bridge’s saturated fill had expanded due to freezing conditions, causing further cracking in the arch barrels and spandrel walls. The stream bed at the piers had also been scoured (Fig. 3).

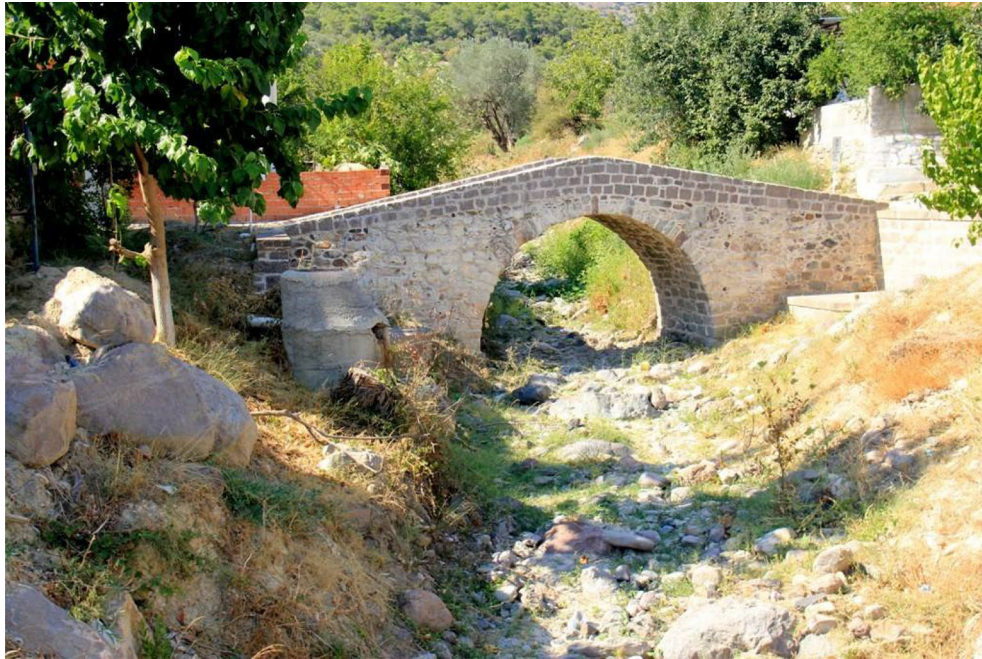
Fig. 4 Recent View of the Ignedere Bridge

name. The bridge has recently been renovated and is in good condition.

The single span stone arch structure is 16 m long and 2.4 m wide, with a circular arch of 4.92 m radius. The bridge is made of large, rough, local stones that have been shaped. The surfaces of the front of the bridge

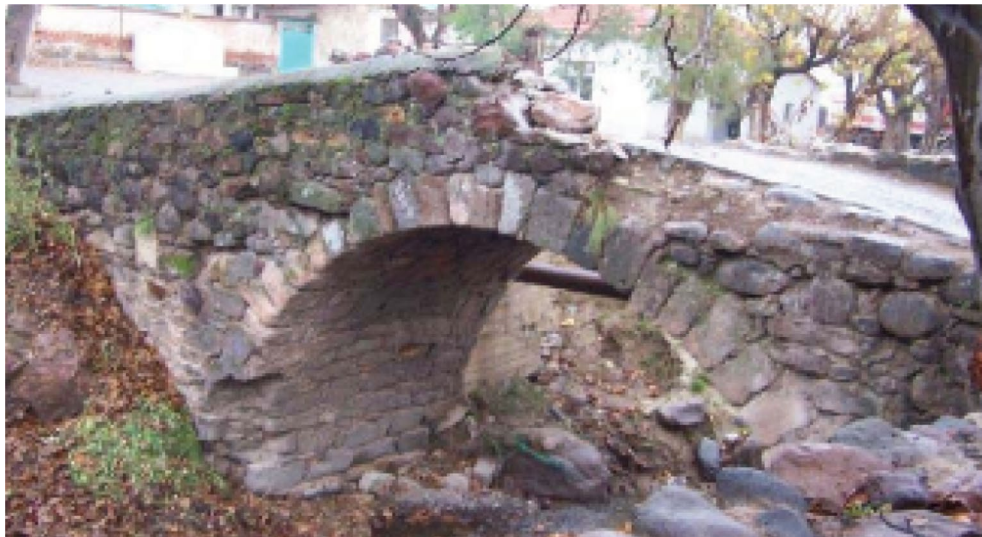
Fig. 5 Previous View of Ignedere Bridge before restoration

Visual examination showed that the bridge had suffered mortar discharges in the rubble stone wall and loss of stones, leading to stone fractures. The pebbles, which were pressed into the rubble masonry, had become exposed, leading to ruptures in places (Fig. 5).

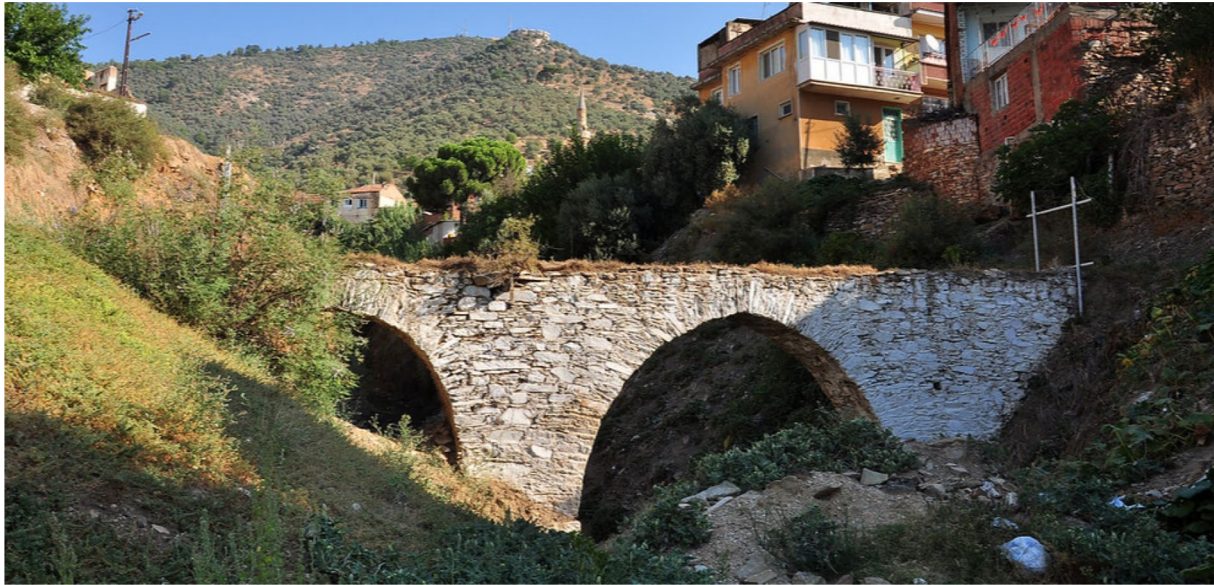
Fig. 6 Front View of Yahudi Deresi Bridge

The third case study bridge, called Yahudi Deresi Bridge, built in the Byzantine period at an unknown date, is located in Bayindir, Izmir. It was built over a creek for the purpose of transportation (Fig. 6).

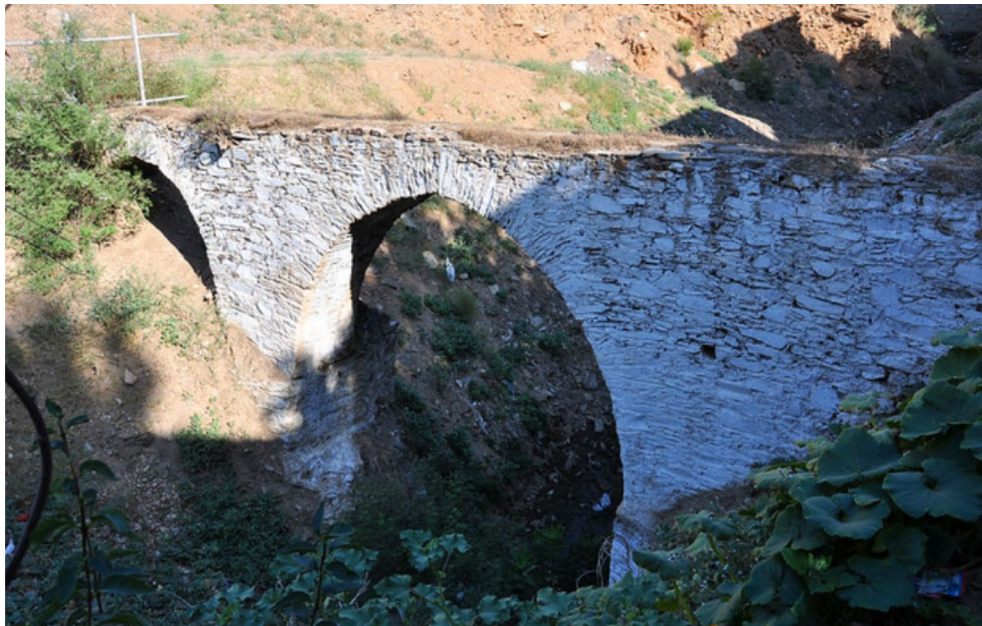
Fig. 7 Back View of Yahudi Deresi Bridge

The stone arch structure has a single lane and is 16 m long, and 2.4 m wide with two span (Fig. 7). The

visual inspection showed that, Yahudi Deresi Bridge is an excellent example of a historic structure that still performs its original purpose, since it forms part of the village’s pedestrian road network.

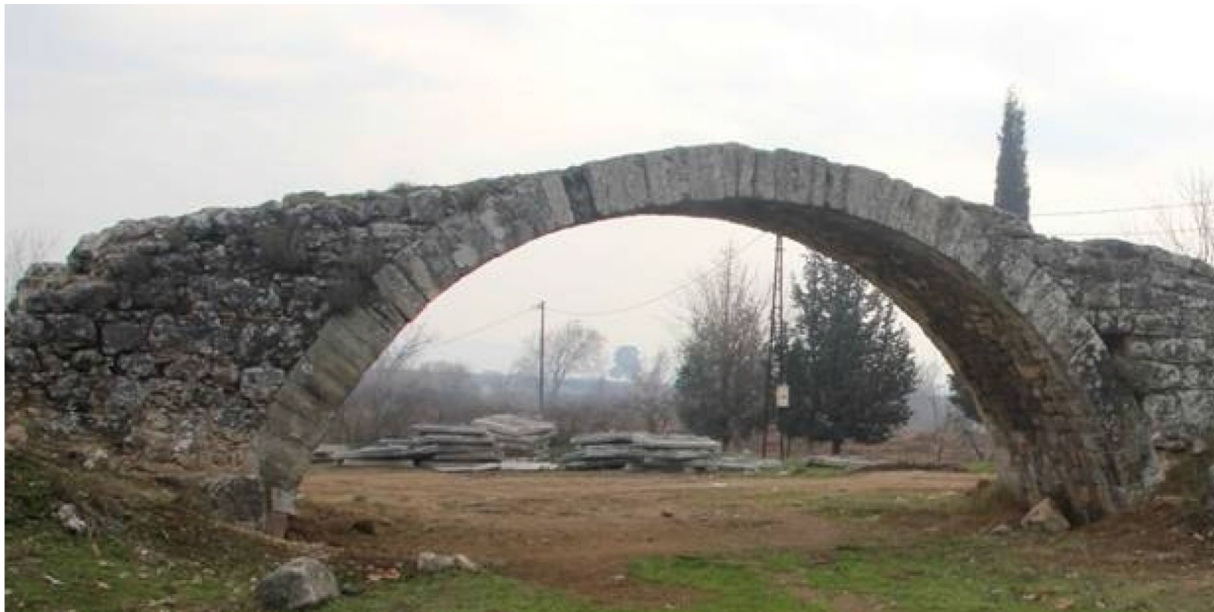
Fig. 8 Front View of Sarikemer Stone Bridge

of Menderes district in Izmir, although it is no longer functional (Fig. 8).

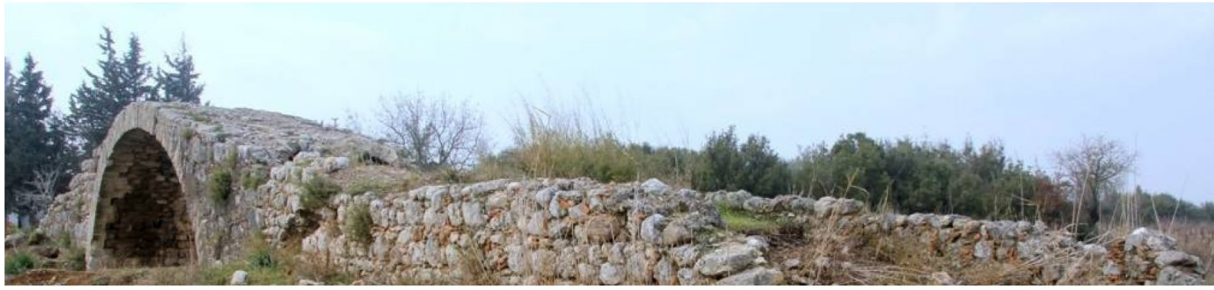
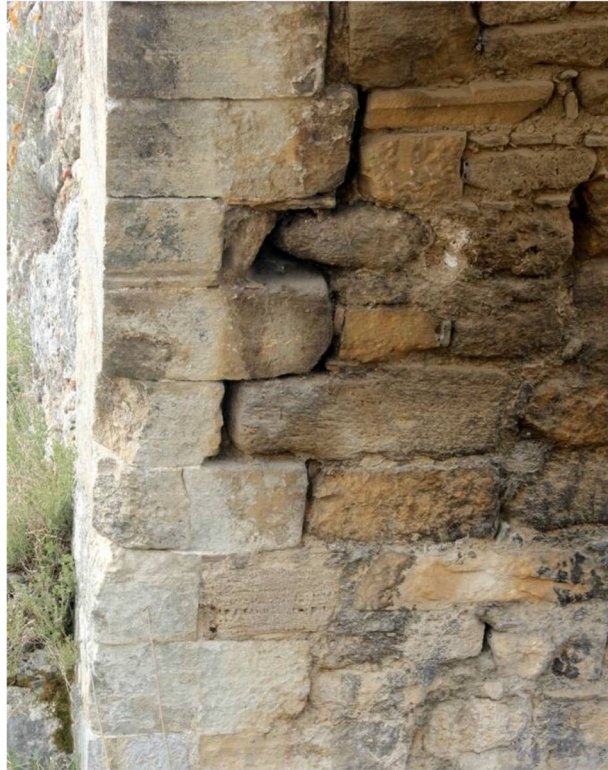
Fig. 9 **a** Side View of the Sarkemer Stone Bridge, **b** View of the bridge pier

The bridge was built in the Byzantine period and the visual inspection revealed an attractive-looking structure of cut stone with a single span, 24 m long, and 8.8 m wide. Its characteristic yellow arch is represented on the flag of the Menderes district (Fig. 9).

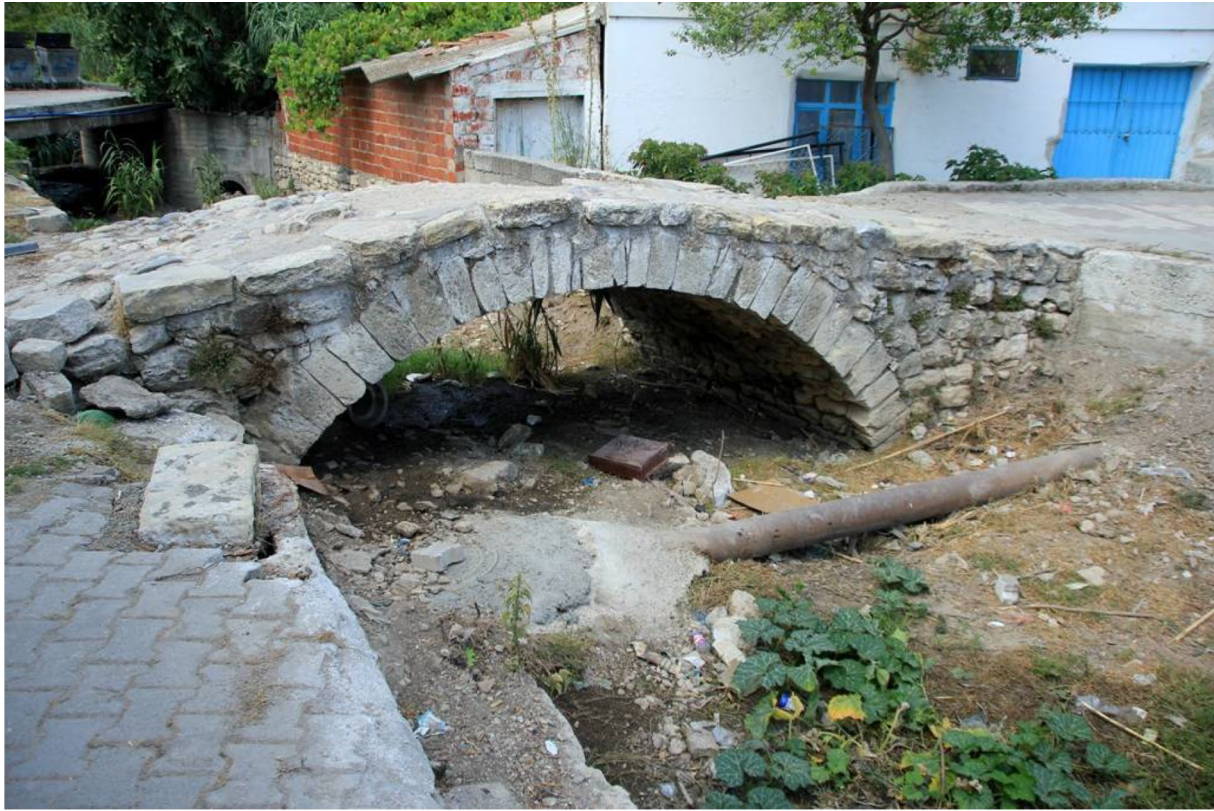
Fig. 10 View of Ozbek Village Bridge

The fifth case study bridge is called Ozbek Village Bridge which has a single-span, and is 8 m long, and 2.4 m wide. Located in Ozbek village, Urla district, Izmir, its construction date is unknown. (Fig. 10).

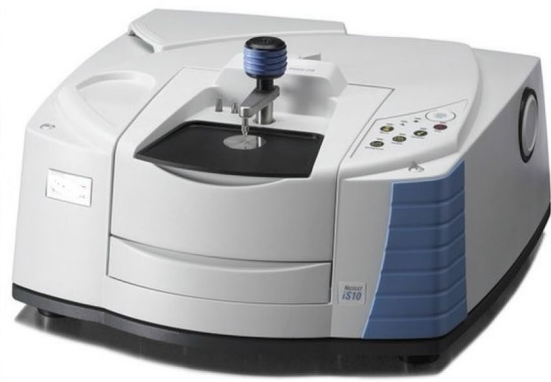
Fig. 11 **a** FTIR Spectrometer in use, **b** FTIR Spectrometer

Because FTIR spectral data collection is complex, fundamental variations inside samples may go undetected, hence feature extraction is critical (Fig. 11).

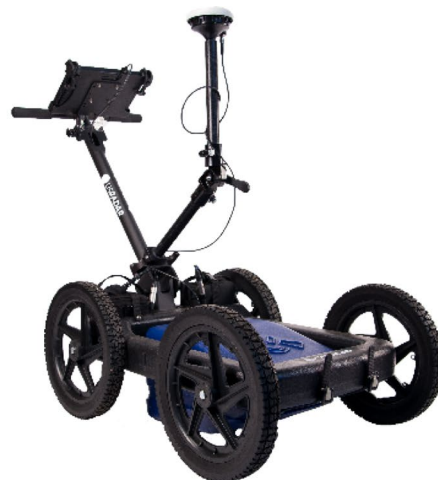
Fig. 13 a TR HF GPR Antenna, b USRADAR GPR Antenna

In this study, the primary goal was to detect concealed fractures or moisture penetration. The survey was conducted with a TR HF model (a 2 GHz antenna), and USRADAR GPR (4 GHz antenna) (see Fig. 13a). To prepare for the GPR survey, straight longitudinal and transverse survey were painted on the surface with a temporary shade, ensuring that the entire area was covered and the data could be referenced to fixed positions (see Fig. 13b).

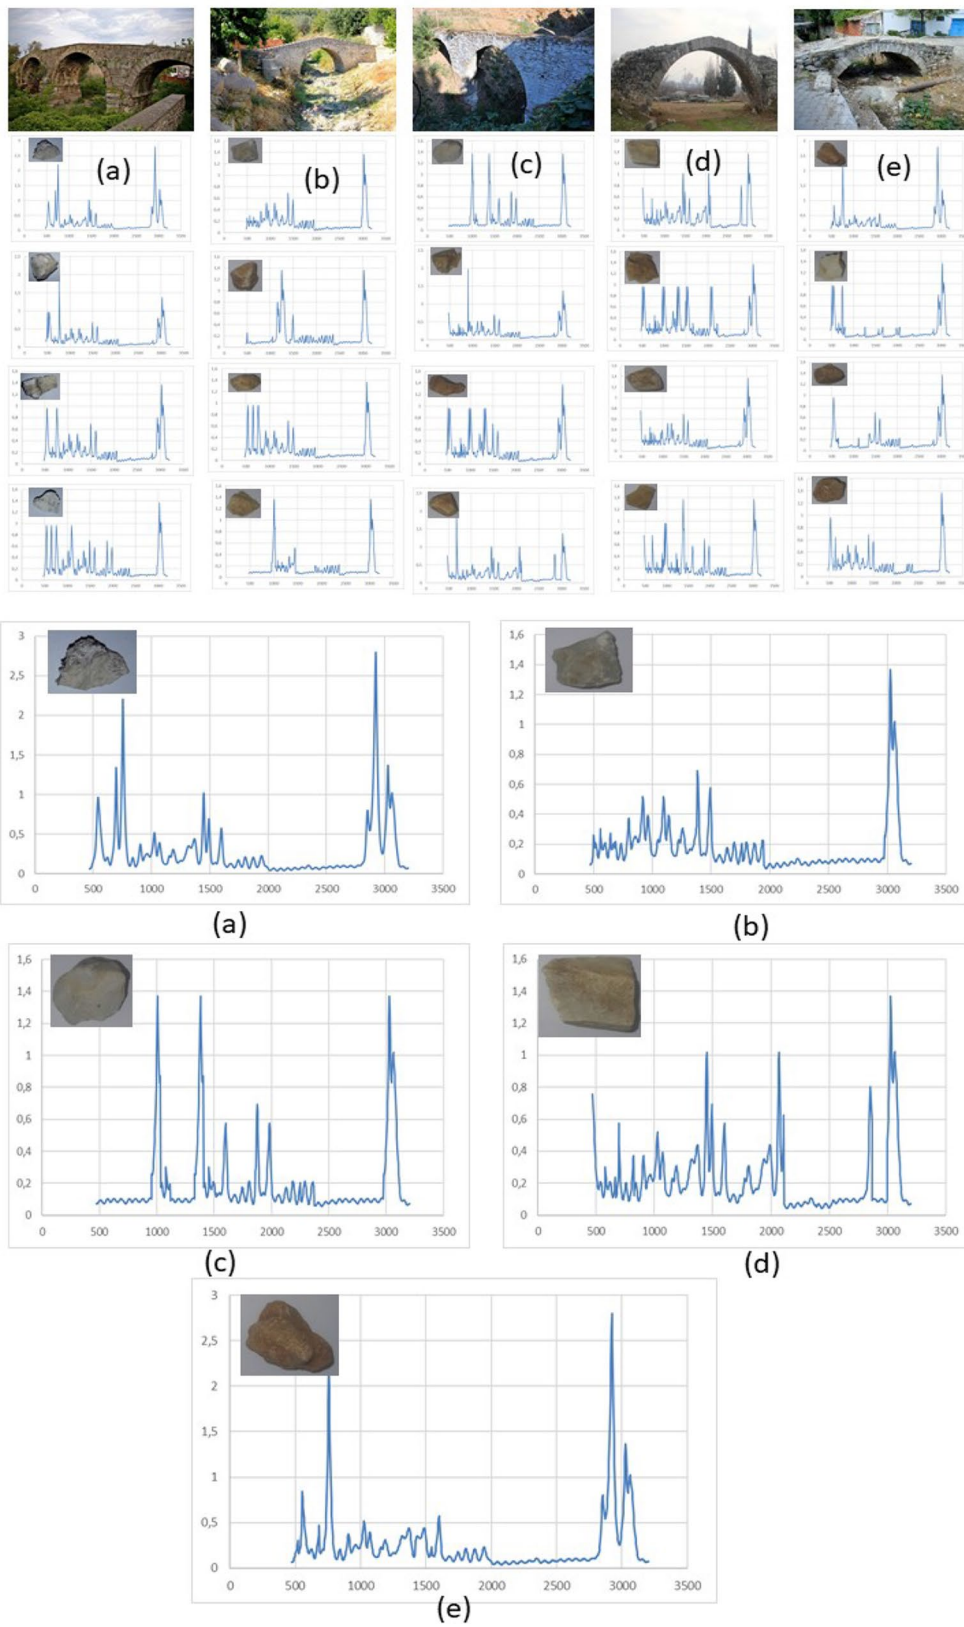
Fig. 14 FTIR Spectra of the samples

The IR spectra revealed the presence of varying levels of calcite (ca. 1230 cm^{-1}) and quartz (685, 676 and 627 cm^{-1}) in every sample. Some samples also had gypsum (ca. 3320, 3504, 1214, 1116, 667, and 622 cm^{-1}) or considerable volumes of calcite. In several samples, the FTIR spectra differed for the interior and exterior sides. Figure 14 shows the FTIR spectra of the pieces with high levels of calcite, gypsum, and differences between outside and insides. The first graphs of each bridge displayed in more detail under the Fig. 14a–e.

Studies of historic bridges generally report equal quantities of plant- and mineral-tempered stone samples in all samples [14], but in the present study, the upper levels had far fewer mineral-tempered stone samples. The usage of organic temper is indicated by the cavities in the

cross divisions, as seen in the Fig. 14. The coarse calcite granules may have been added to the clay raw material in the mineral materials [15]. These granules could be either ordinary, such as carbonate sand, or purposefully derived from the stone samples, by fracturing carbonate rocks or calcite veins, depending on the use of the stone samples [14–16].

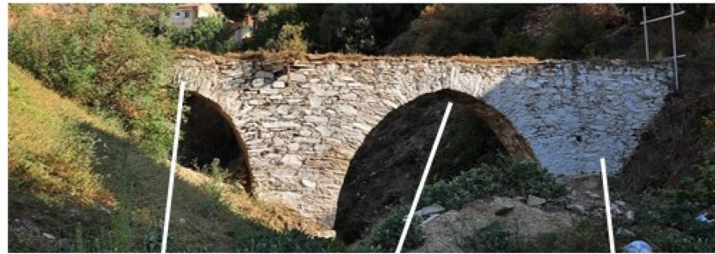
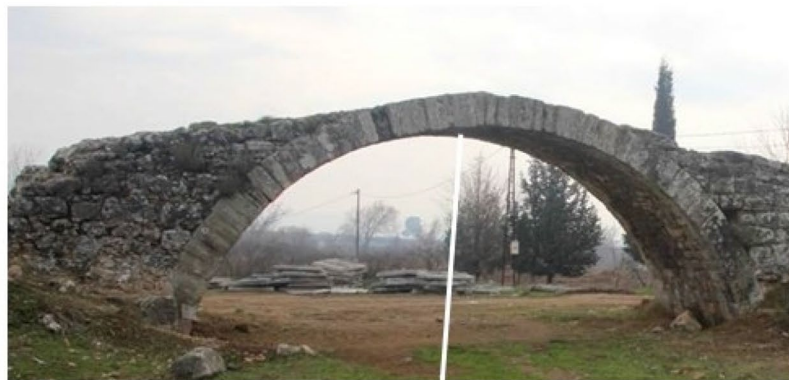
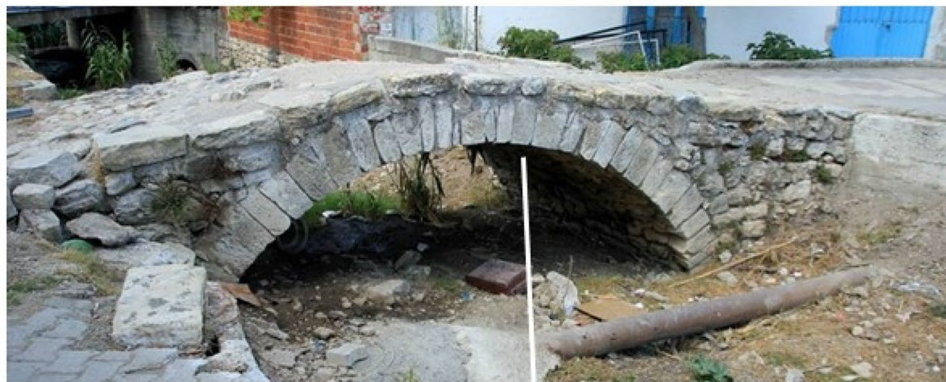
The center cross-section of the radargram shown in Fig. 15 was obtained from the GPR scan at the case study bridges. The radargram clearly shows the old bridge arches and material modifications. The interpretation is

depicted in Fig. 15a–e. Following a more individualized processing step for each profile, spots in the data with strong reflectors were manually identified as coarse fill materials inside the bridge.

The GPR receiving antenna collected several radar rebounds, which may have restricted and obscured abnormality signals, as can be seen in the GPR radargram shown in Fig. 15. The layers and locations showing potential damage by moisture entry are clearly marked.

The facade masonry and the ashlar facing had distinct structural traits while the analyzed piece of the facade had inner and outer stone faces concealing a rubble core. The irregularities detected in the ashlar facing of the case study bridges were probably caused by cracks, voids, or defective mortar.

investigated using GPR and Thermal camera technology. The radargrams (Fig. 15) generated by processing the GPR data illustrate the usefulness of two different manufacturers’ GPR antennas in giving vital structural information, however they are unable to provide details such as grain size and quality. Thermal imaging (Fig. 16) is a low-cost, rapid method of detecting surface and interior abnormalities. However, environmental conditions such as wind, intense sunshine, and rain can seriously affect the accuracy of this technology.

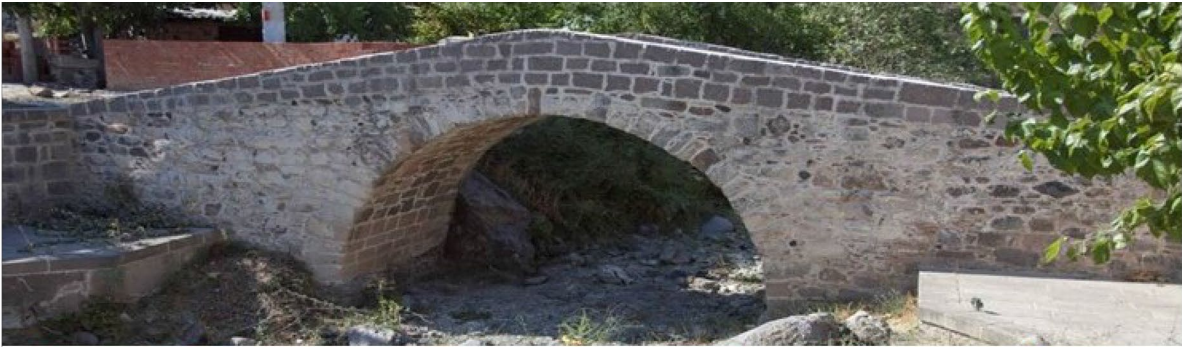
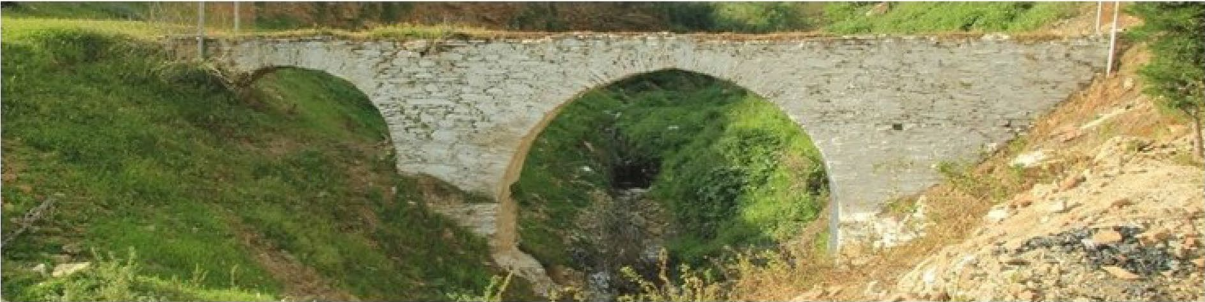
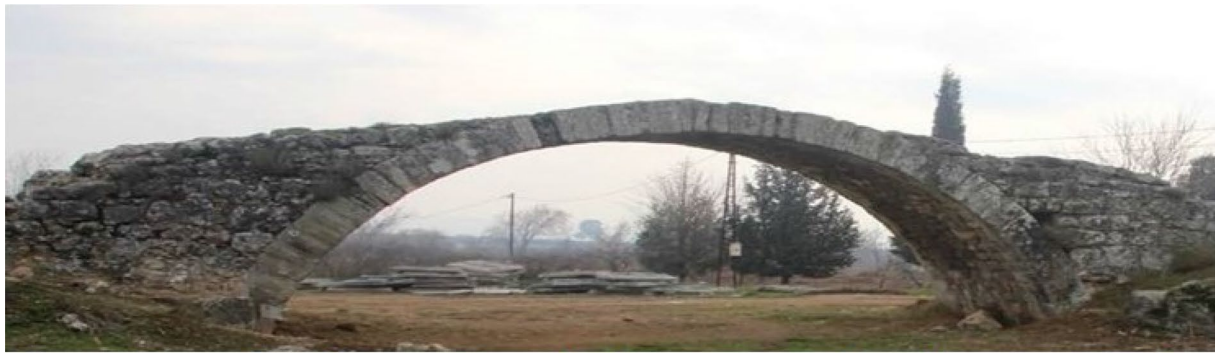
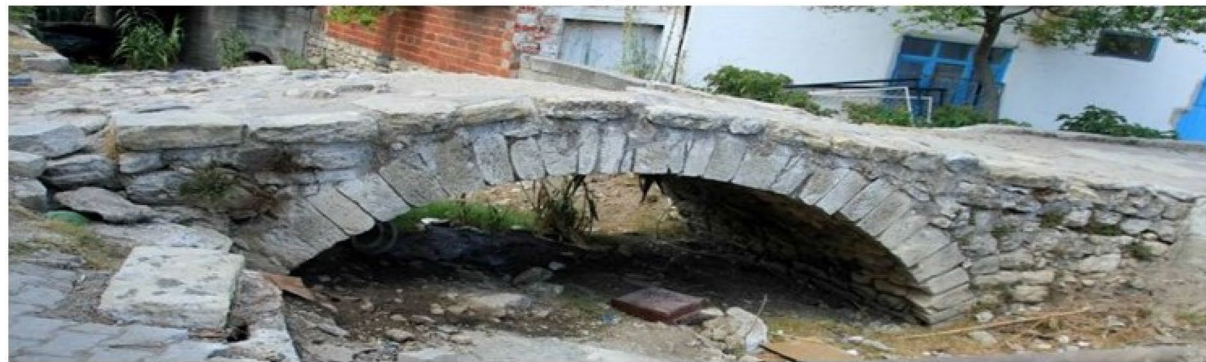
Fig. 16 Position of the moisture, and delamination **a** Case Study 1, **b** Case Study 2, **c** Case Study 3, **d** Case Study 4, **e** Case Study 5

The thermal imaging examination revealed concrete degradation, cover delamination, water seepage, and large fractures. The thermal camera was employed in the historical case study, where the observed ambient temperature was 18 °C and the ambient moisture content was around 48%. The use of this technology showed and corroborated the location of cracks, delamination, and faults that were discovered during the visual inspection (see Fig. 16). The delamination found here represents a case of natural IR active thermography, which is associated with daily temperature variations and the establishment of varied temperature gradients between delaminated and non-delaminated regions (Fig. 16).

In addition, delamination and objectivities of the mural were discovered. The presence of stored heat (see Fig. 16)

indicated that sections within the fractures in this location had become separated, necessitating rapid repair work to prevent further degradation and potentially permanent damage.

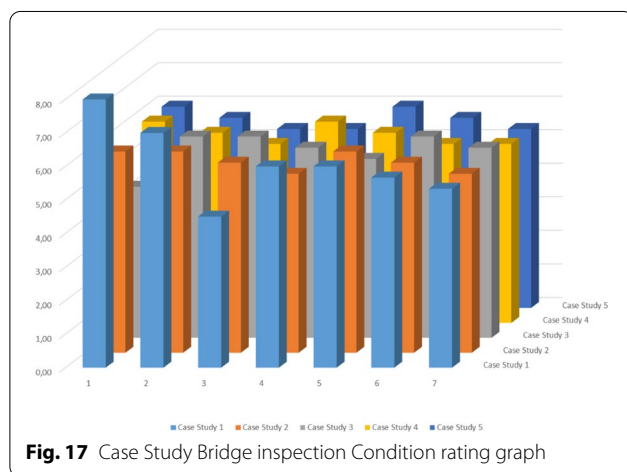
Fig. 17 Case Study Bridge inspection Condition rating graph

Table 1 and Fig. 17 exhibit the author’s suggested bridge inspection rating card. In a view of concerns over the decay of historic bridge components, and how long the structure can survive without them, several coefficients are applied to identify the components most in need of attention. The inspection-grading card provides condition ratings of bridge components at various levels, as well as an overall bridge grade. Table 1 and Fig. 17 indicate the subgroup circumstances that are considered
