Assessment of historic buildings after an earthquake using various advanced techniques

Gokhan Kilic ^{*}

Department of Civil Engineering, Izmir University of Economics, Izmir, Turkey

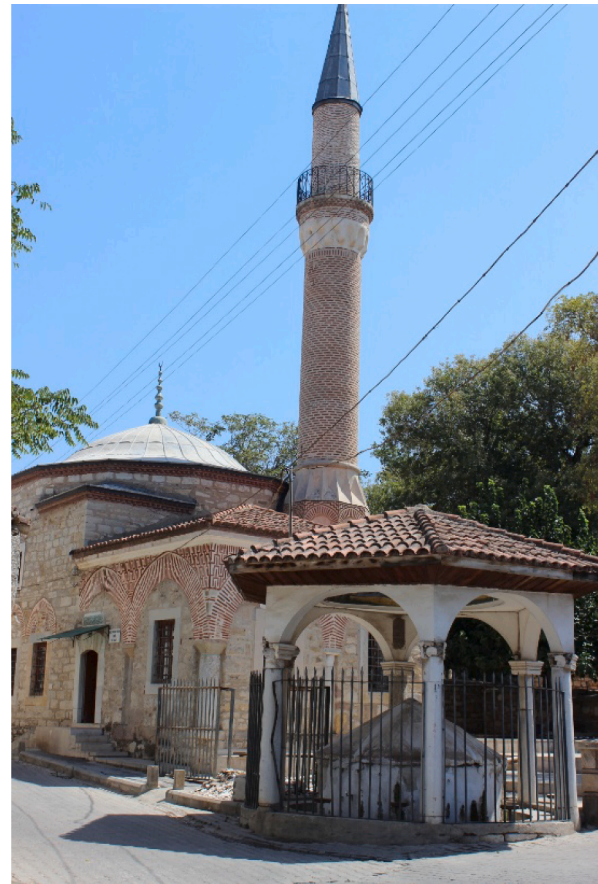
Fig. 5. Front View of case study 1 building.

The first case study was the Izmir-Urta Haci Turan Kapan Mosque (Fig. 5), a historic Ottoman structure constructed in the mid-16th century and then extended on two sides in the 19th century [49]. The original central part was connected to the new sections via several arched corridors, built at various times before and after the extensions. The mosque has a square design with a single dome supported on an octagonal shaft and composed of cut stone and rubble stone. The sanctuary is illuminated by three rectangular windows at the lowest level and one on each side of the mosque-mihrab. The three-sectioned tiled narthex to the north has a minaret whose base extends as far as the dome pulley. The mosque courtyard was demolished to make way for a road and square, but the original fountain remains intact next to the road.

Each structural section of the building was visually assessed internally and externally, revealing that the material used were masonry, comprising brick, stone, and mortar. Among the defects discovered were degradation, water seepage, cover delamination, and large zones of cracking. Delamination-induced degradation was also discovered, necessitating repairs to the structure's west façade and the whole

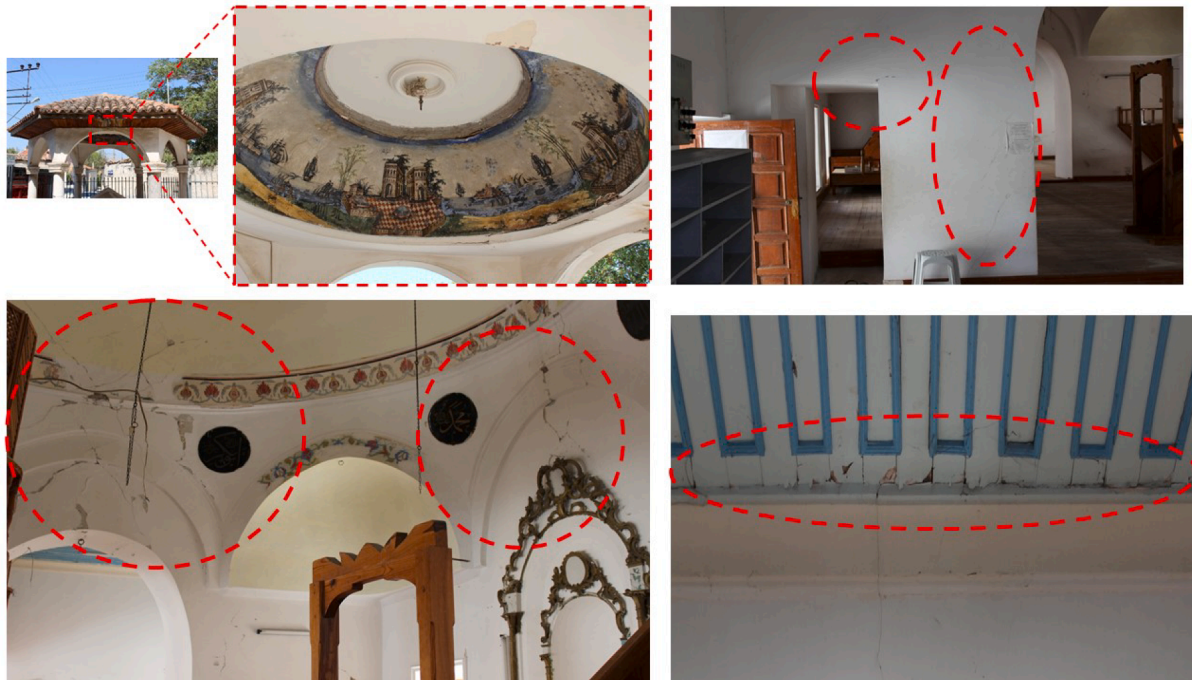
ceiling. One very large crack and other deformations can be seen in Fig. 6.

Fig. 6. Case study 1: Serious crack inside the structure and other deformations.

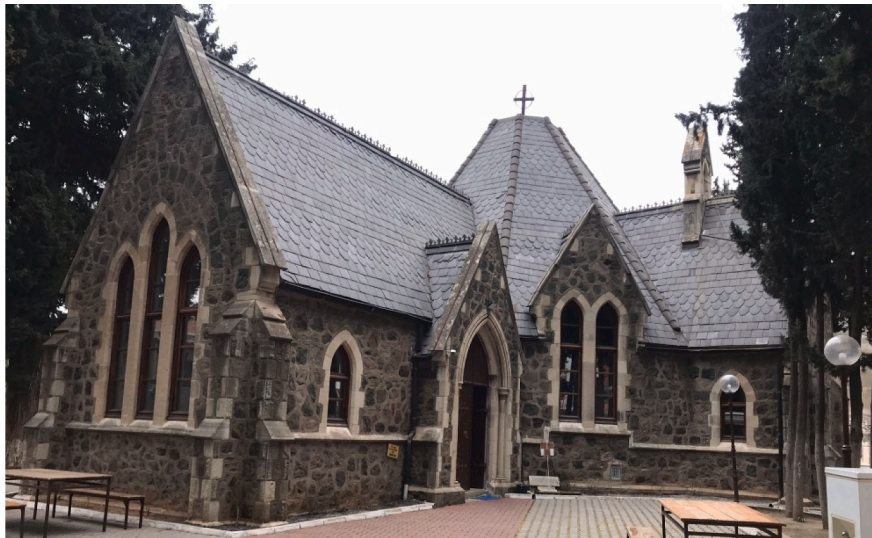
Fig. 7. Front View of case study 2 building.

Buca Protestant Baptist Church was founded in 1834 as an independent Protestant Anglican church before being rededicated as a Baptist church. Its original structure was that of a small village church in the form of a chafel “chapel”. It was renovated following an edict issued by Abdulaziz, the then Ottoman sultan, in 1865 [50] and used as a place of worship until 1961. In 1865, it was transferred to Buca Municipality and used as a wedding hall and cultural centre [51]. In 2001, an agreement was made to restore the building as a functioning church (Fig. 7).

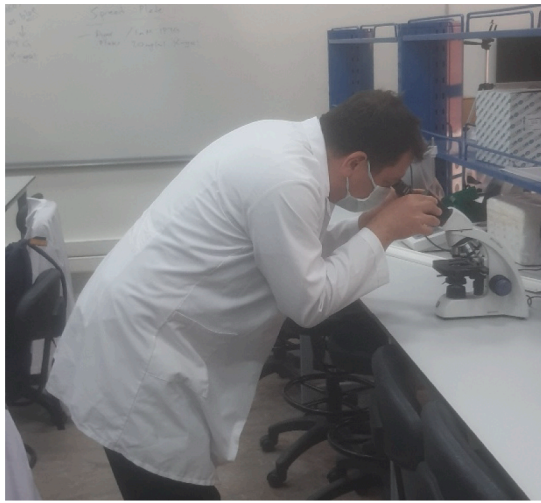
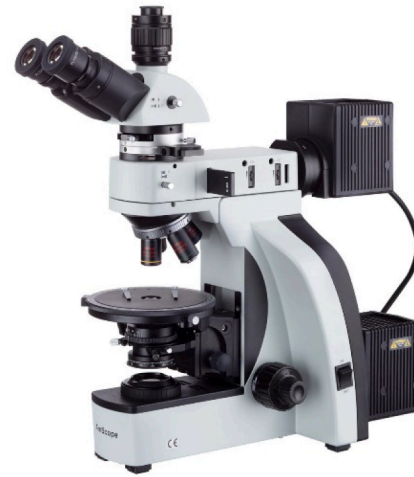
Fig. 14. (a) Polarized optical Microscope in use, (b) Polarized optical microscope.

Thin sections of the two case structures were prepared specifically the stone/rock, mortar, plaster, and ceramic (tiles and bricks) samples for examination under an optical microscope. Thin sections of the samples prepared for petrographic micromorphological studies, and also to show all layers from the material's surface to the interior. These examinations were conducted with a LEICA Research Polarizing Microscope Model DMLP top and bottom-illuminated optical microscope connected to a DFC280 digital camera (in parallel and crossed nicol with 2.5x magnification) (Fig. 14) [53].

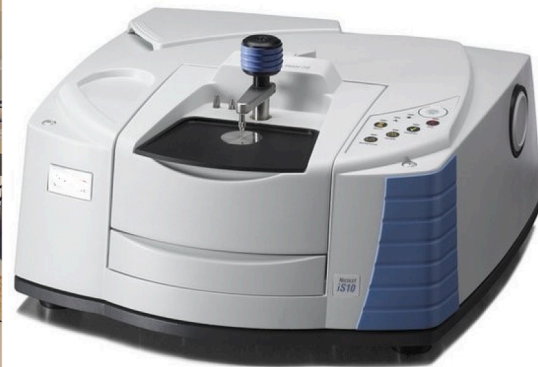
Fig. 15. (a) FTIR Spectrometer in use, (b) FTIR spectrometer.

Due to the complexity of FTIR spectral data collecting, basic differences within samples may go unnoticed, hence feature extraction is essential (Fig. 15). The findings are more interpretable after using multivariate statistical analysis to minimize the number of variables acquired from the IR spectral data. In this study, a combination of verified and unverified approaches were used [38,39].

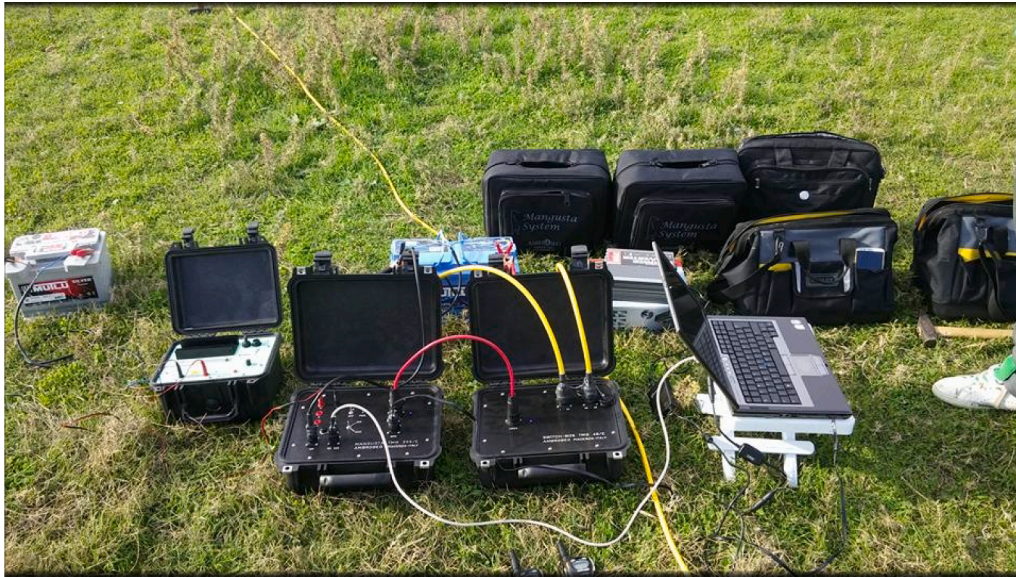
Fig. 16. Ambergeor brand's Mangusta TMG 255 E model multi-electrode (48 electrode capacity) resistivity tomography device.

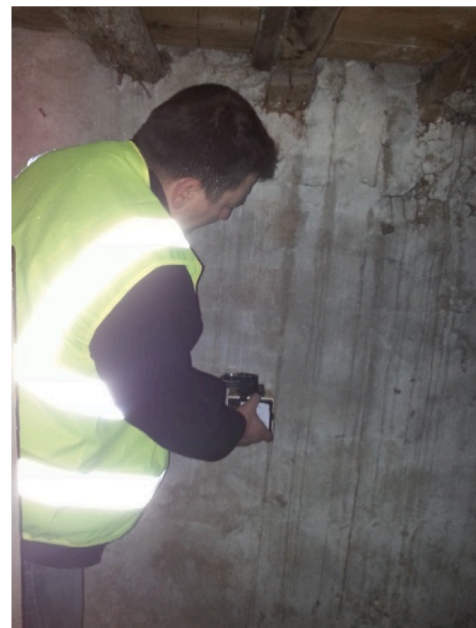
The main purpose of the present study was to find hidden cracks or moisture infiltration. A TR HF type 2 GHz GPR system was used for the survey (Fig. 18.a). To prepare for the GPR survey, conventional longitudinal and transverse surveys were painted on the surface with a temporary shadow, ensuring that the whole region was covered and that the data could be linked to specific locations (Fig. 18.b) [55].

Fig. 18. (a) TR HF GPR antenna, (b) GPR in use.

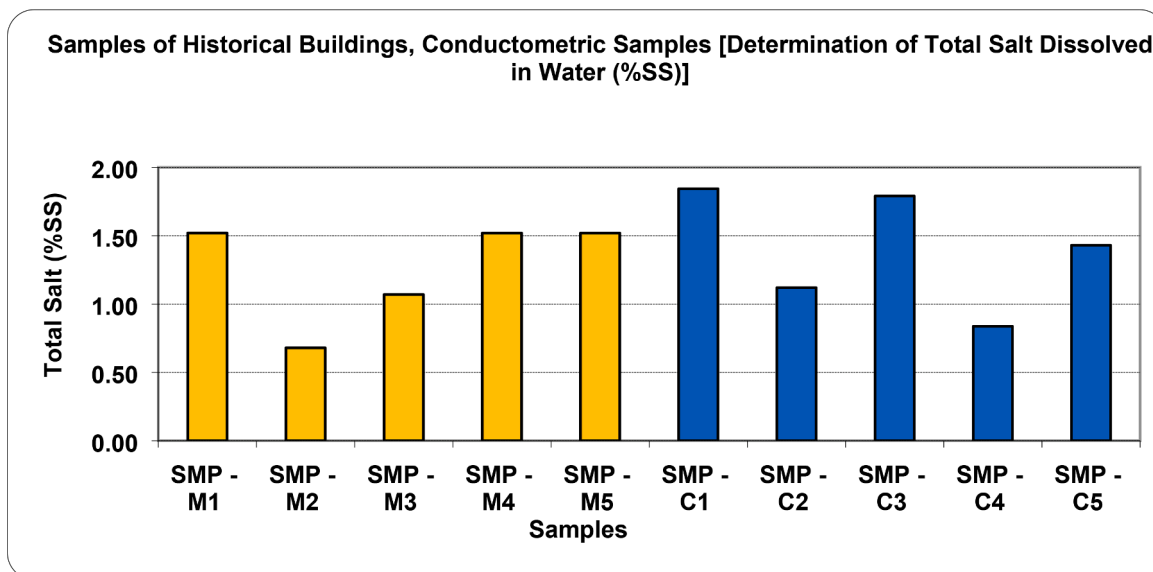
The water-soluble salt contents and types and the ambient pH values of the stone and ceramic (tile and bricks) specimens are given in Table 2. The amount of water-soluble salt (total) contained in the structure (pores) of the stone and ceramic (tile and bricks) materials in the structures studied was determined quantitatively (Table 3 and Fig. 21).

Fig. 21. Samples of Determination of Total Salt Dissolved in Water (%SS).

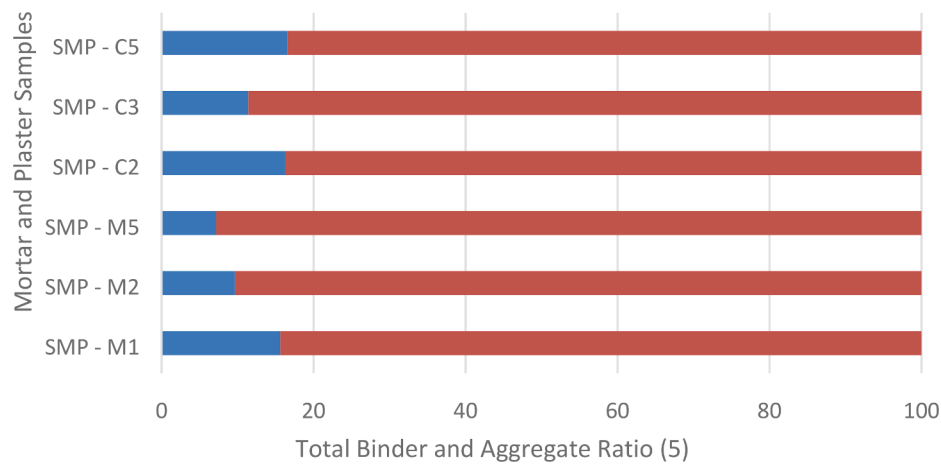
Fig. 22. Mortar and Plaster Samples of Acidic Aggregate / Binder Analysis.

- Lime mortar should be used for joint repairs and crack filling in the building's façade masonry. This should contain 25 percent lime by weight, 45 percent toothed/fractured, sieved, washed, with an aggregate distribution consistent with the original mortar (39 percent max. 1–2 mm coarse, 60 percent 63–1000 m grained silt/sand, and 1 percent). The recommendation is for lime mortar with a silt/clay combination with 63 m grains at a rate of 63 m) and rock-free aggregate with carbonate content, crushed and sieved limestone fragments at 20 percent, and brick fragments at 10 percent. In terms of strength, the use of broken bricks is completely adequate in internal plasters and in external mortars, but organic additions in the original mortar are not advised.

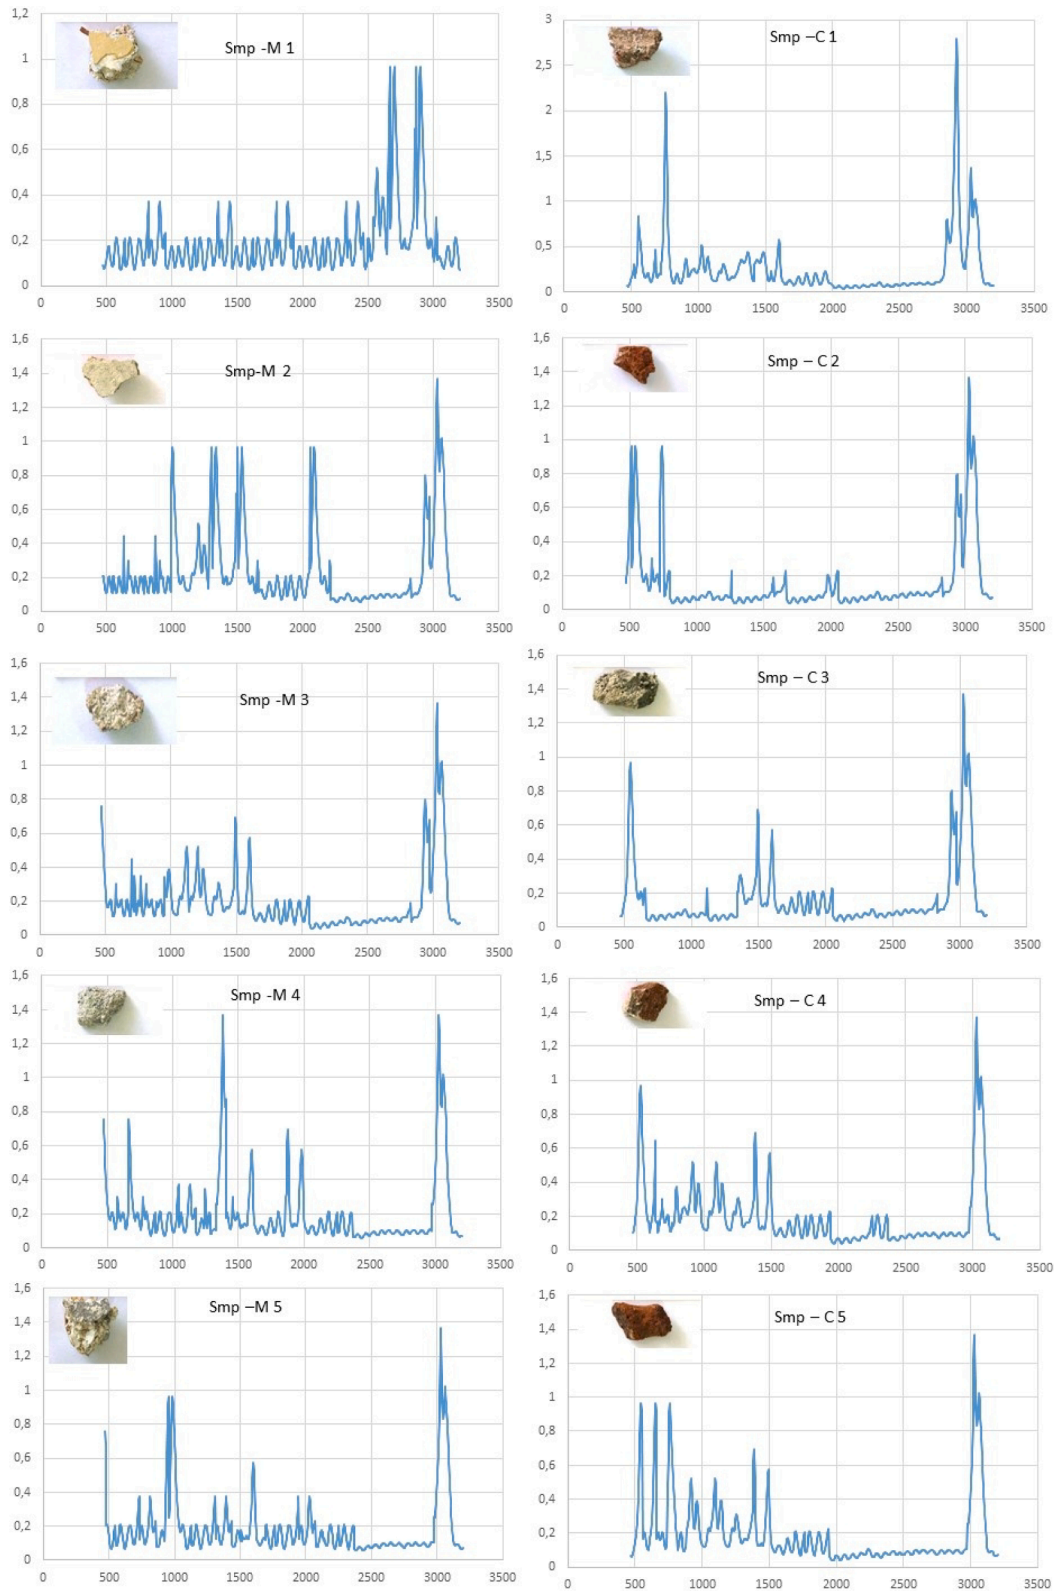
to provide a smooth surface for FTIR spectroscopic examination. It was then washed with alcohol before a 1 mg sample was scraped. Based on the IR spectra, the samples had varying quantities of calcite (about 1150 cm^{-1}) and quartz (596 , 625 , and 656 cm^{-1}). Some samples included gypsum (ca. 2820 , 3315 , 1156 , 1108 , 640 , and 618 cm^{-1}) or large amounts of calcite (ca. 2820 , 3315 , 1156 , 1108 , 640 , and 618 cm^{-1}). Fig. 24 shows that the FTIR spectra for the interior and exterior surfaces of various samples varied. It shows the FTIR spectra of the sections with high calcite and gypsum levels, as well as revealing discrepancies between the exterior and the insides.

Fig. 24. FTIR Spectra of the samples.
