Quantitative evaluation of the damage to RC buildings caused by the 2023 southeast Turkey earthquake sequence

Earthquake Spectra

2024, Vol. 40(1) 505–530

DOI: 10.1177/87552930231211208

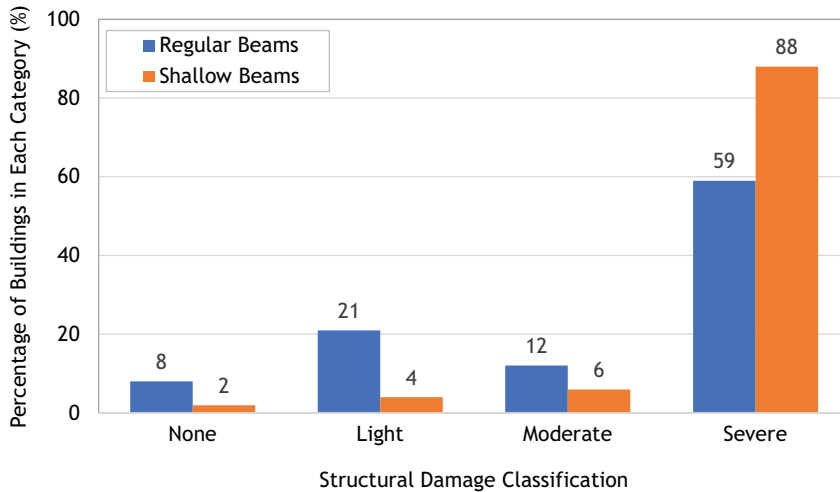
Observations are organized in Figure 4 to show the distribution of damage classifications for surveyed buildings with regular and shallow-beam frames. Evidently, the frequency of severe damage was higher among buildings with shallow beams (88% compared

Figure 4. Damage frequency observed in reinforced concrete frames with regular beams and shallow beams (critical and collapsed structures are included within the bin labeled “severe”).

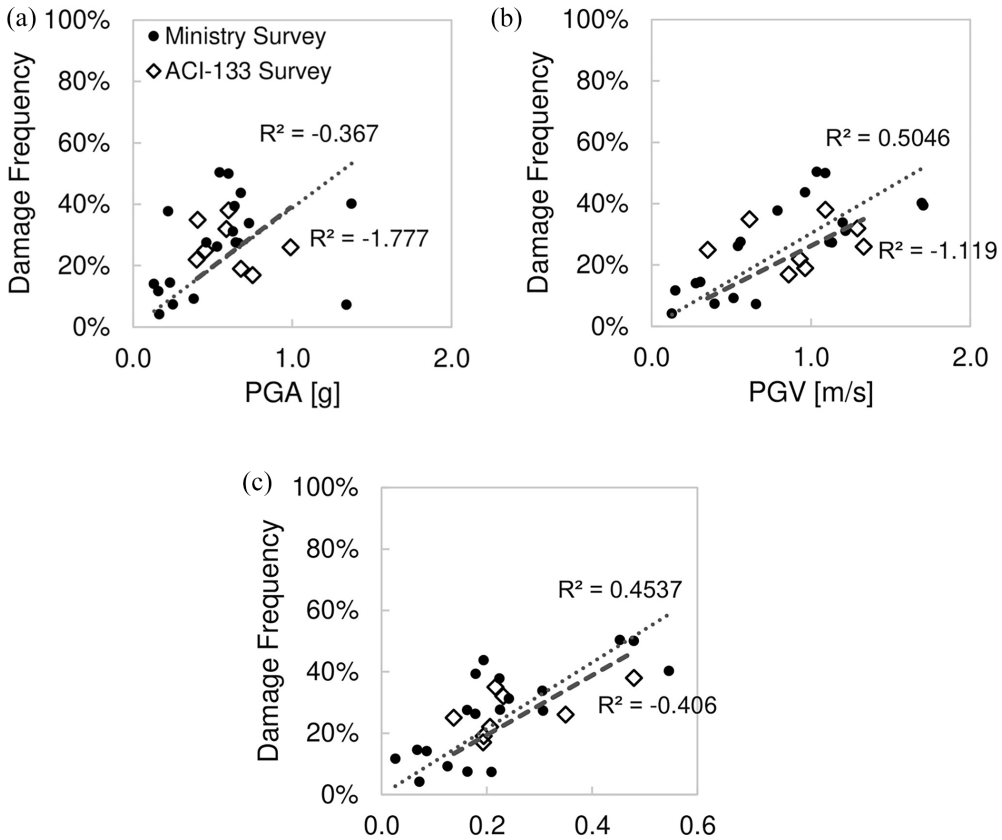
In general, spectral ordinates for $T = 0.3$ s did not produce better correlations with frequency of damage than spectral ordinates for $T = 1$ s. Spectral accelerations (S_a) and spectral velocities (S_v) for $T = 1$ s produced correlations comparable with the correlations seen for spectral displacement (S_d) at 1 s. PGV produced correlations better than those for PGA, and similar to those for S_d at 1 s. Given the mentioned differences in the surveys, a good match between the two sets of data on damage frequency was not expected. What matters more is whether both sets of data produce the best correlations with observed damage for the same intensity measure(s). They did, with PGV and S_d at 1 s producing better correlations for both surveys. PGV has the advantage of being simple. Recall that PGA often requires “corrections” or has to be expressed in terms of an “effective” value

Figure 6. Correlations between damage intensities and intensity: (a) peak ground acceleration as the intensity measure, (b) peak ground velocity as the intensity measure, and (c) spectral displacement (S_d) for a period of 1 s and damping ratio of 2%.

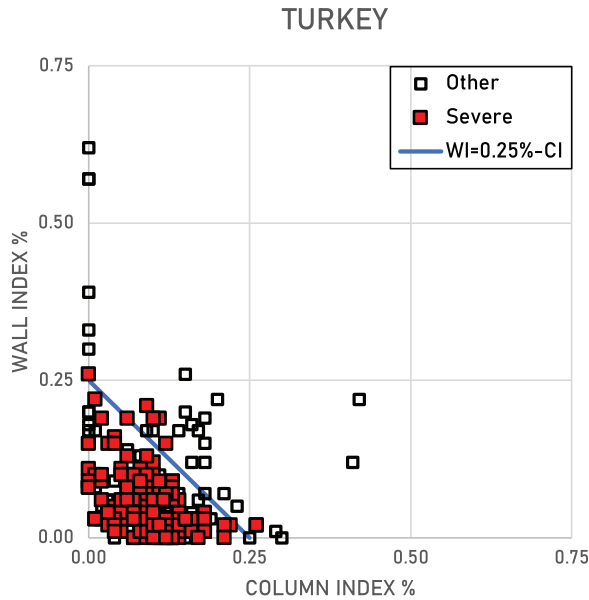
Figure 7 shows CI versus WI for buildings from all the visited cities. A line at $WI = (0.25\% - CI)$ similar to what Hassan and Sozen (1997) recommended (1) would fall above most of the data points, and (2) reasonably bound the buildings observed to have severe damage. Figure 8a and 8b groups data by cities where the intensity of the ground motion was high (Nurdagi, Turkoglu, Kirikan, Hassa, Antakya, and Islahiye, where PGV exceeded 50 to 60 cm/s) and cities where the intensity was low (Gaziantep, Kahramanmaras, Malatya, and Elbistan, where PGV did not exceed 50 to 60 cm/s). The points representing buildings with severe damage are closer to the origin for the latter group of cities. In their cases, the line $WI = (0.2\% - CI)$ would be above most of the buildings observed to have severe damage. Nevertheless, the lack of data points with CI close to zero and $(1/8)\% < WI < 0.3\%$ in Figure 8b does not allow for a stronger statement.

Figure 7. Column index versus wall index for buildings surveyed by ACI-I33 in 2023.

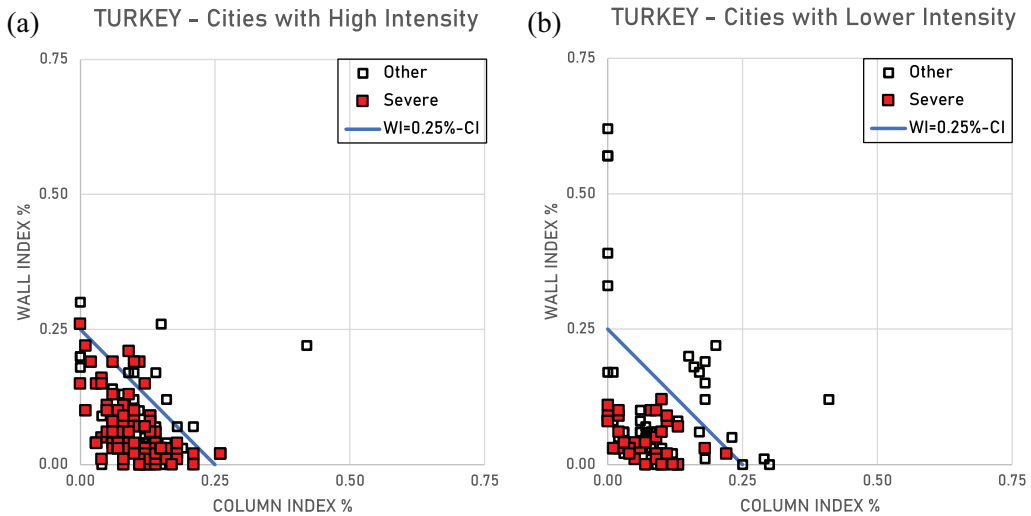
Figure 8. Data separated for cities subjected to (a) high and (b) low ground-motion intensities.

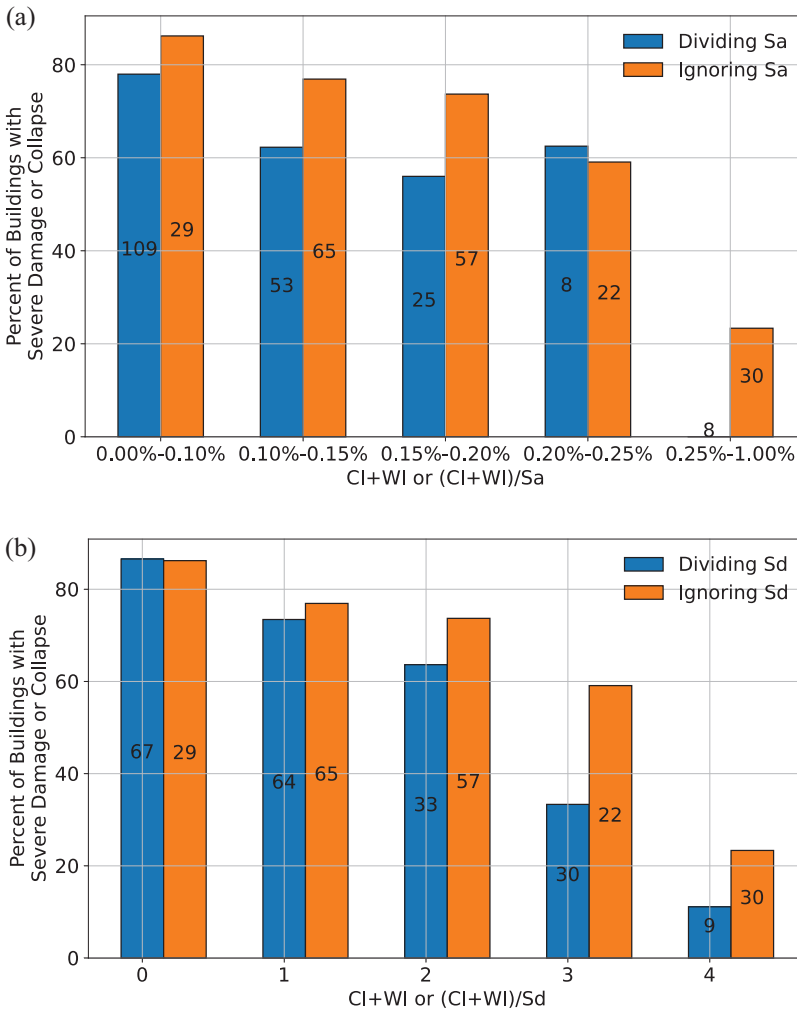
The chart in Figure 9a shows that the correlation between damage frequency (among surveyed buildings) and the sum $PI = WI + CI$ is not improved in a clear fashion if PI is divided by spectral acceleration (S_a) (in g) at a period $T = N/10$ ($N =$ number of stories).

Figure 9b is similar to Figure 9a, except that it was produced by dividing PI by S_d (in m) instead of S_a (at $T = N/10$). The correlation between damage frequency and PI/S_d appears to be stronger than the correlation between damage frequency and PI . Values of S_a and S_d assigned to each building were obtained from the acceleration record obtained at the station closest to the building. The distances between buildings and stations were estimated using the Haversine formula. Buildings with no stations within 30 km were excluded from Figure 9.

Figure 9. Damage distribution versus PI , PI/S_a , and PI/S_d : (a) damage distribution among surveyed buildings versus PI and PI/S_a , and (b) damage distribution among surveyed buildings versus PI and PI/S_d . PI : priority index.

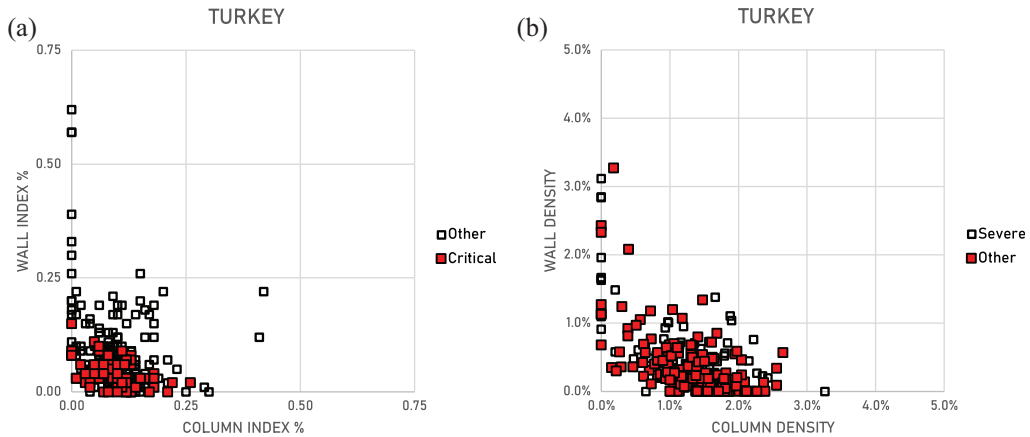
Perhaps more interestingly, the points representing buildings with critical damage (as defined above) are quite close to the origin and the x-axis of the $WI-CI$ plot (Figure 10a). Approximately 96% of buildings classified as having critical damage had $WI \leq 0.1\%$. Wall density and column density (defined with the same numerators as WI and CI and typical floor area as denominator) did not help organize the data better (Figure 10b). Even though the WI and CI had been calibrated—until now—for buildings with 7 or fewer stories, the same observation is made for buildings with more than 7 stories. The evidence in this section confirms once more that $WI + CI$ can be used to prioritize retrofit efforts. It would seem imperative to start with all buildings with $WI < 0.1\%$ in zones where the expected demands (whether measured in terms of S_a , S_d , or PGV) are high.

Figure 10. (a) Wall index versus column index for buildings with critical damage and (b) data organized as column density versus wall density.

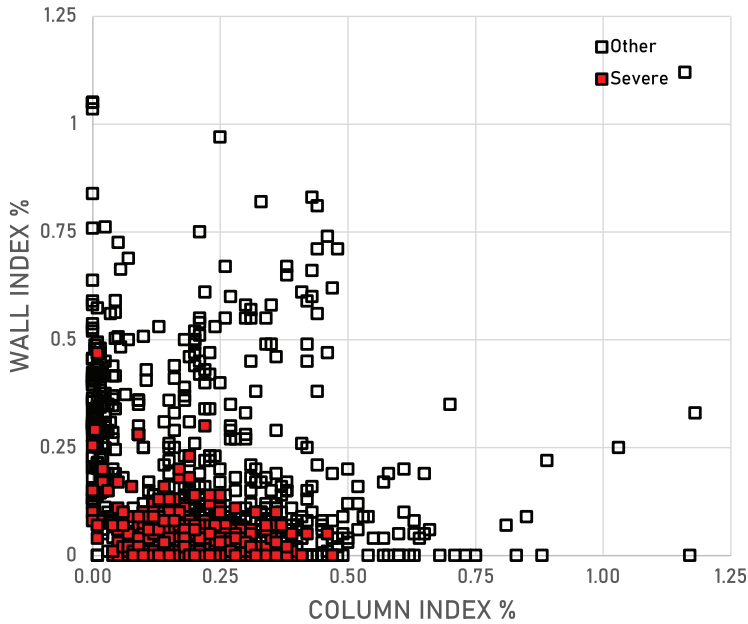
Figure 11. Column index versus wall index for 1639 buildings across 15 earthquakes.

differences among damage classification scales and methods are likely to contribute to the scatter in the data. Nevertheless, the results show a trend similar to the trend in Figure 7, with severely damaged buildings concentrated mostly in the area between the origin and the line $WI = (0.25\% - CI)$.

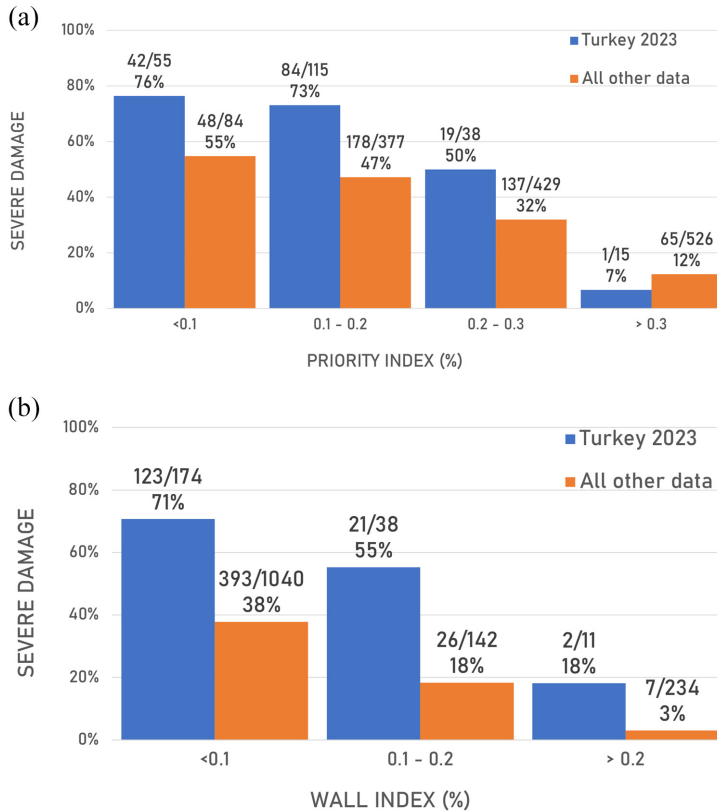
Figure 12a and b illustrates the percentage of surveyed buildings classified as having severe damage versus PI and WI . Fractions above bars refer to the number of buildings classified as having severe damage (numerator) and the total number of buildings in each bin (denominator). The illustrated data show that increases in PI and WI have been consistently associated with reductions in the numbers of buildings with severe damage. Less than 4% (9/245) of all surveyed buildings with $WI > 0.2\%$ had severe damage, compared with $\sim 40\%$ (563/1394) for $WI < 0.2\%$. Similarly, $\sim 12\%$ (66/541) of all surveyed buildings with $PI > 0.3\%$ had severe damage, compared with $\sim 46\%$ (508/1098) for $PI < 0.3\%$. Approximately 65% (90/139) of all surveyed buildings with a $PI < 0.1\%$ were classified as having severe damage. Approximately 90% (516/572) of all severely damaged buildings had a $WI < 0.1\%$.

Figure 12a and b make a direct comparison between buildings surveyed in Turkey in 2023 and other buildings surveyed. Both sets of data exhibit a reduction in severely damaged buildings as PI and WI increase. Nevertheless, the percentage of severely damaged buildings was noticeably higher in Turkey in 2023. This is likely due to the larger demands recorded in Turkey, with an average $PGV \sim 90 \text{ cm/s}$ across all the surveyed sites and the lack of robustness in the surveyed buildings. Only 7% (15/223) of buildings recently surveyed in Turkey had $PI > 0.3\%$, while the rest of the data set had 37% (526/1416) of buildings in that category. Similarly, $\sim 5\%$ (11/223) of buildings recently surveyed in Turkey had $WI > 0.2\%$, while $\sim 17\%$ (234/1416) of the buildings in the rest of the data set had $WI > 0.2\%$. These figures suggest that buildings recently surveyed in Turkey were, on

Figure 12. Percentage of surveyed buildings that were severely damaged versus (a) priority index and (b) wall index for the Turkey 2023 Earthquake and the combined data set.

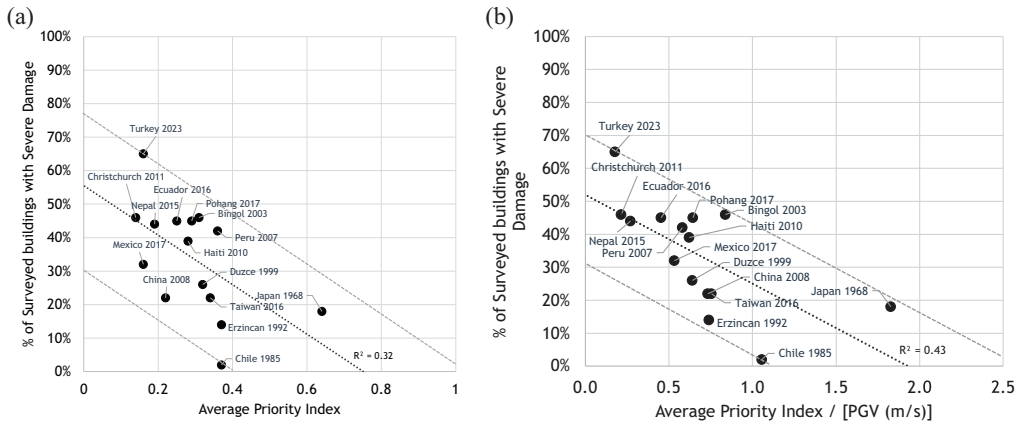
Figure 13a shows the percentage of surveyed buildings classified as having severe damage after each considered event (Table 4) versus the average PI . Despite the chaotic nature and the complexity of the earthquake problem, Figure 13a can be used to suggest a general trend going from the upper left corner (large % of buildings having severe damage and small PI) down to the bottom right of the plot (low % of severely damaged buildings and large PI). The results reinforce the idea that as PI increases, the frequency of severe damage decreases despite the large number of relevant factors not included in the plotted data. The scatter in Figure 13a is related to differences in ground-motion intensity. For two sites with a similar average PI , the site with more intense shaking is likely to experience more damage. Consider the numbers for Turkey 2023 ($PGV \sim 90\text{cm/s}$), Christchurch 2011 ($PGV \sim 65\text{cm/s}$), and Mexico ($PGV \sim 30\text{cm/s}$). All three regions had similar average values of PI and WI ; however, the frequency of severe damage was greater in Turkey. Similarly, the 2017 China, and 1985; Mexico, 2008 Chile Earthquakes all had recorded PGV of 30 – 35 cm/s and there is a fairly linear reduction in the frequency of severe damage as average PI increased for these cases. Because of the large range in ground-motion intensity for the various survey sites, with PGV ranging from 30 to 90 cm/s , Figure 13b

Figure 13: (a) Average priority index (%) and (b) average priority index (%) divided by peak ground velocity versus the percentage of severely damaged buildings for each earthquake event.

was plotted to assess the relationship between severe damage and the ratio of average *PI* to average *PGV* (Table 4). Figure 13b suggests a slightly clearer trend than Figure 13a does.

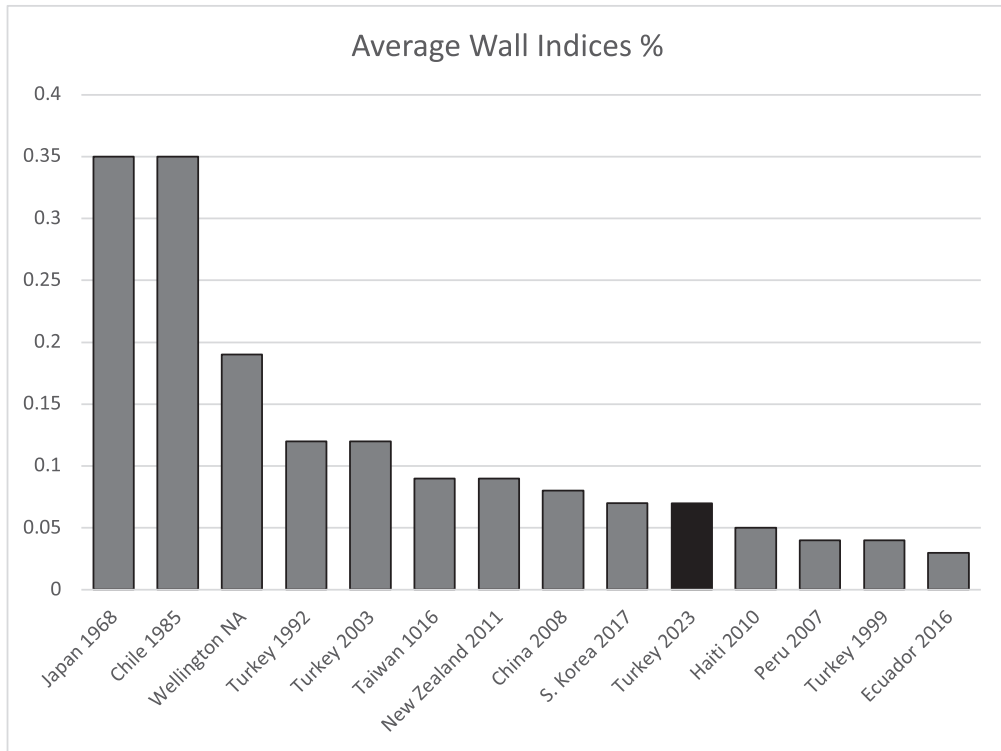
Figure 14 compares the values of *WI* across all the events in Table 4. The figure shows radical disparities relative to the indices observed in Japan and Chile. For reference, consider again that the guidelines published by ACI 314R-16 (2016) include an implicit limit for *WI* of 0.2%. Figure 14 does not show a clear trend to increase building robustness in Turkey since 1992. Because previous surveys in Turkey focused on buildings with 7 or fewer stories, consider for reference that the average values of *PI* and *WI* obtained for buildings of similar height in 2023 are 0.2 and 0.08 (in contrast with 0.17 and 0.07 obtained for the entire sample from 2023). No clear changes in robustness were observed either among buildings built before and after 2018, when the last regulation update was implemented in Turkey.

Figure 14. Comparison of average values of wall index from Turkey 2023, and with other events.
