Experimental Study of the Evolution of the Breach and the Discharge through the Breach Resulting from Piping due to Seepage at the Earth-Fill Dam Bottom

Mehmet Sukru Guney¹, Emre Dumlu², Merve Okan¹, Asli Bor¹, Pelin Aklık¹, Gökmen Tayfur²

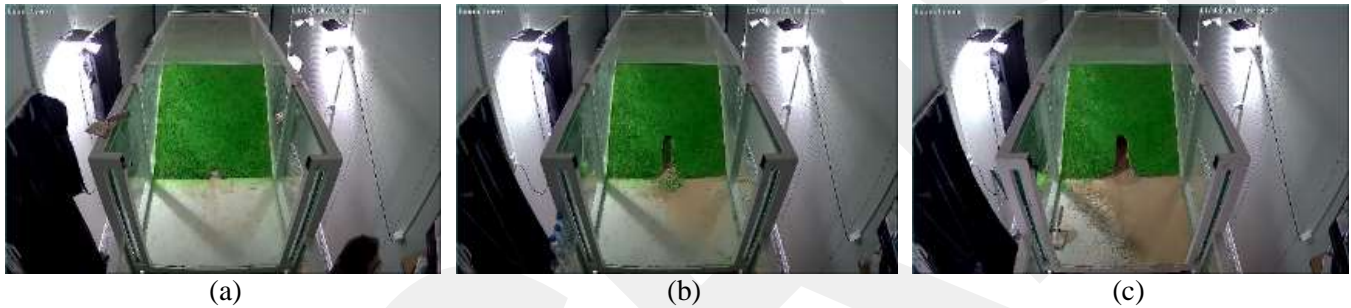
Fig. 6: The temporal development of the breach at downstream a) $t=0\text{ h}$, b) $t=48\text{ h}$, c) $t=230\text{ h}$

The developments of the breach which were recorded by the cameras located at downstream and upstream parts of the dam are given in Fig. 6 and Fig.7, respectively.

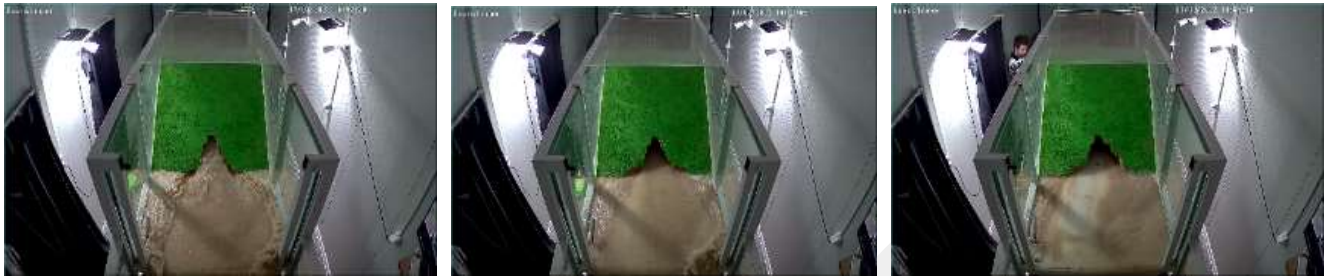
Fig. 8: The temporal development of the breach at the downstream (a) $t=0\text{ s}$, (b) $t=5\text{ s}$, (c) $t=15\text{ s}$

(d) (e) (f)
 Fig.8 (continued): The temporal development of the breach at the downstream (d) 25 s, (e) 60 s, (f) 315 s

The temporal development of the breach at the downstream and upstream parts are given in Fig. 8 and Fig. 9, respectively. The time $t=0$ corresponds to the time at which the breach appeared at upstream face.

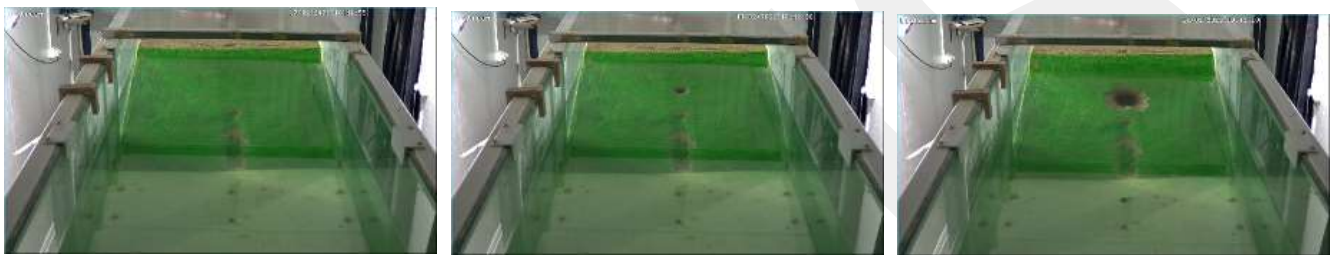
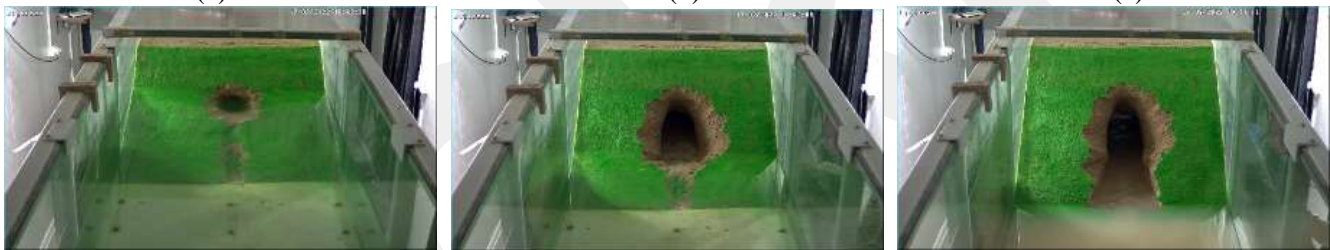
(a) (b) (c) (d) (e) (f)
 Fig. 9: The temporal development of the breach at the upstream (a) $t=0$ s, (b) $t=5$ s, (c) 15 s, (d) 25 s, (e) 60 s, (f) 315 s
